# **Stack Particulate Management Plan Annual Stack Particulate Report**

**Period: July 2019 – June 2020**

**Licensed site:** Adelaide Brighton Cement, Birkenhead Works  
**62 Elder Road, Birkenhead, SA 5015**

**EPA Licence number:** 1126

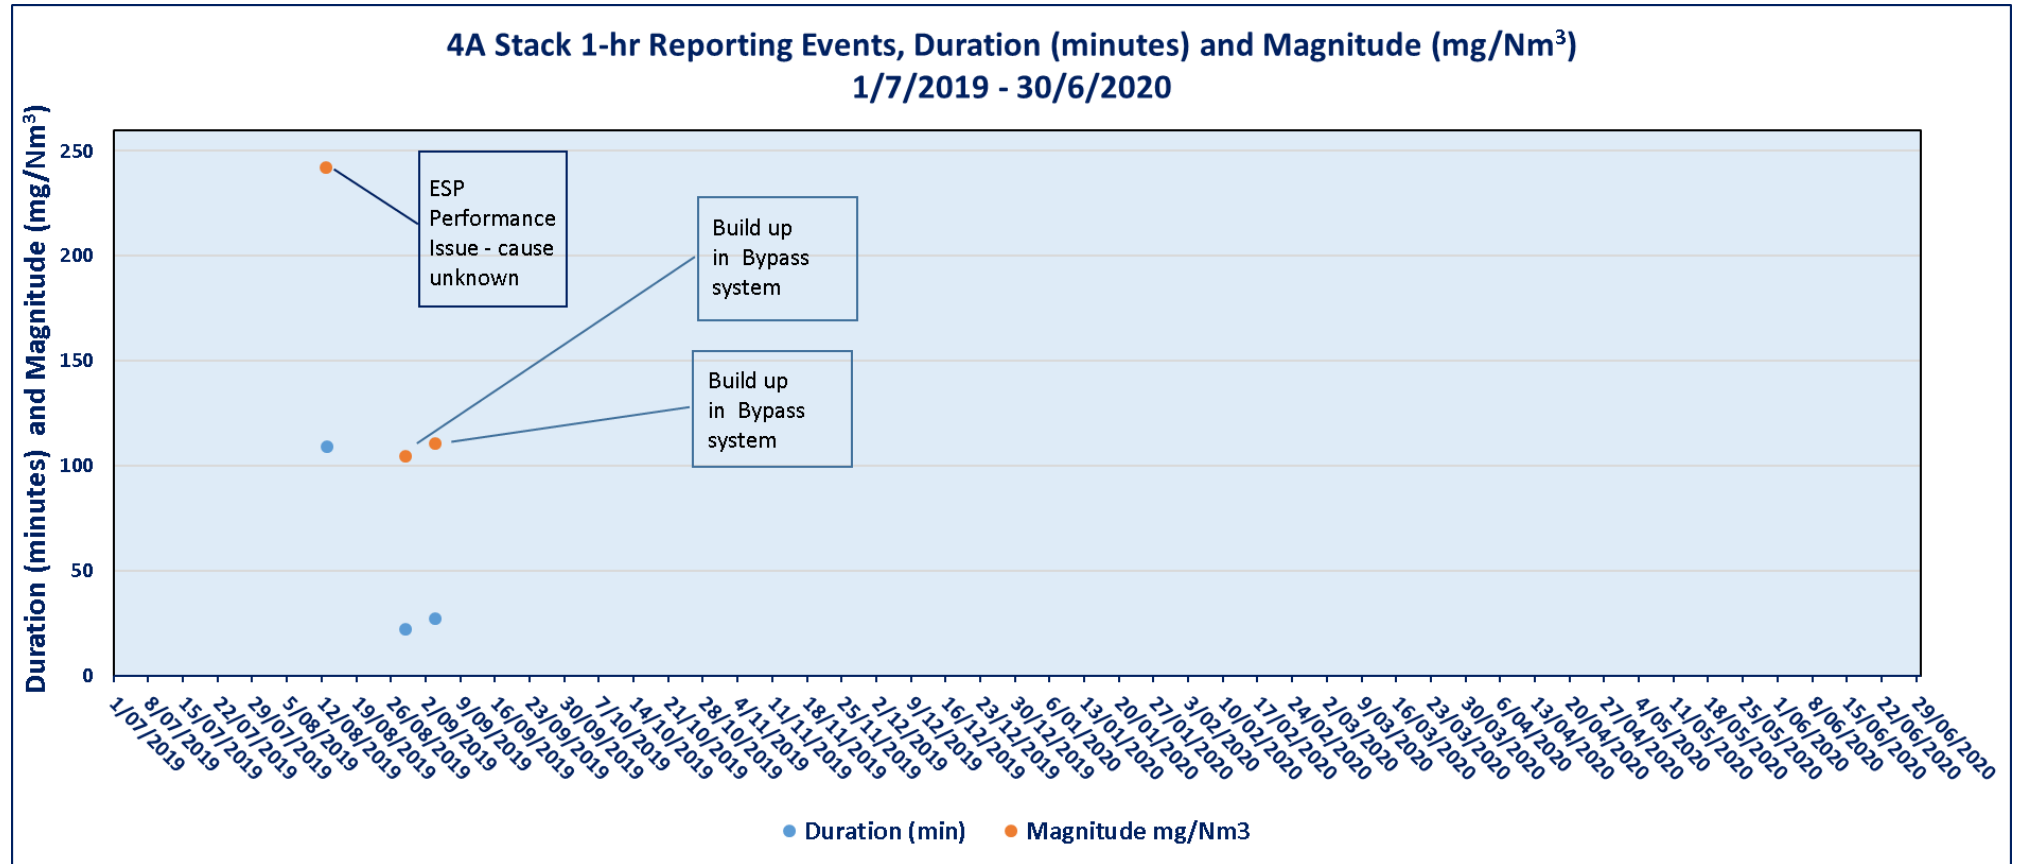
## 4A Stack:

There were 3, 1-hr Reporting events for the year.  
All the 1-hr Reporting events were process related.

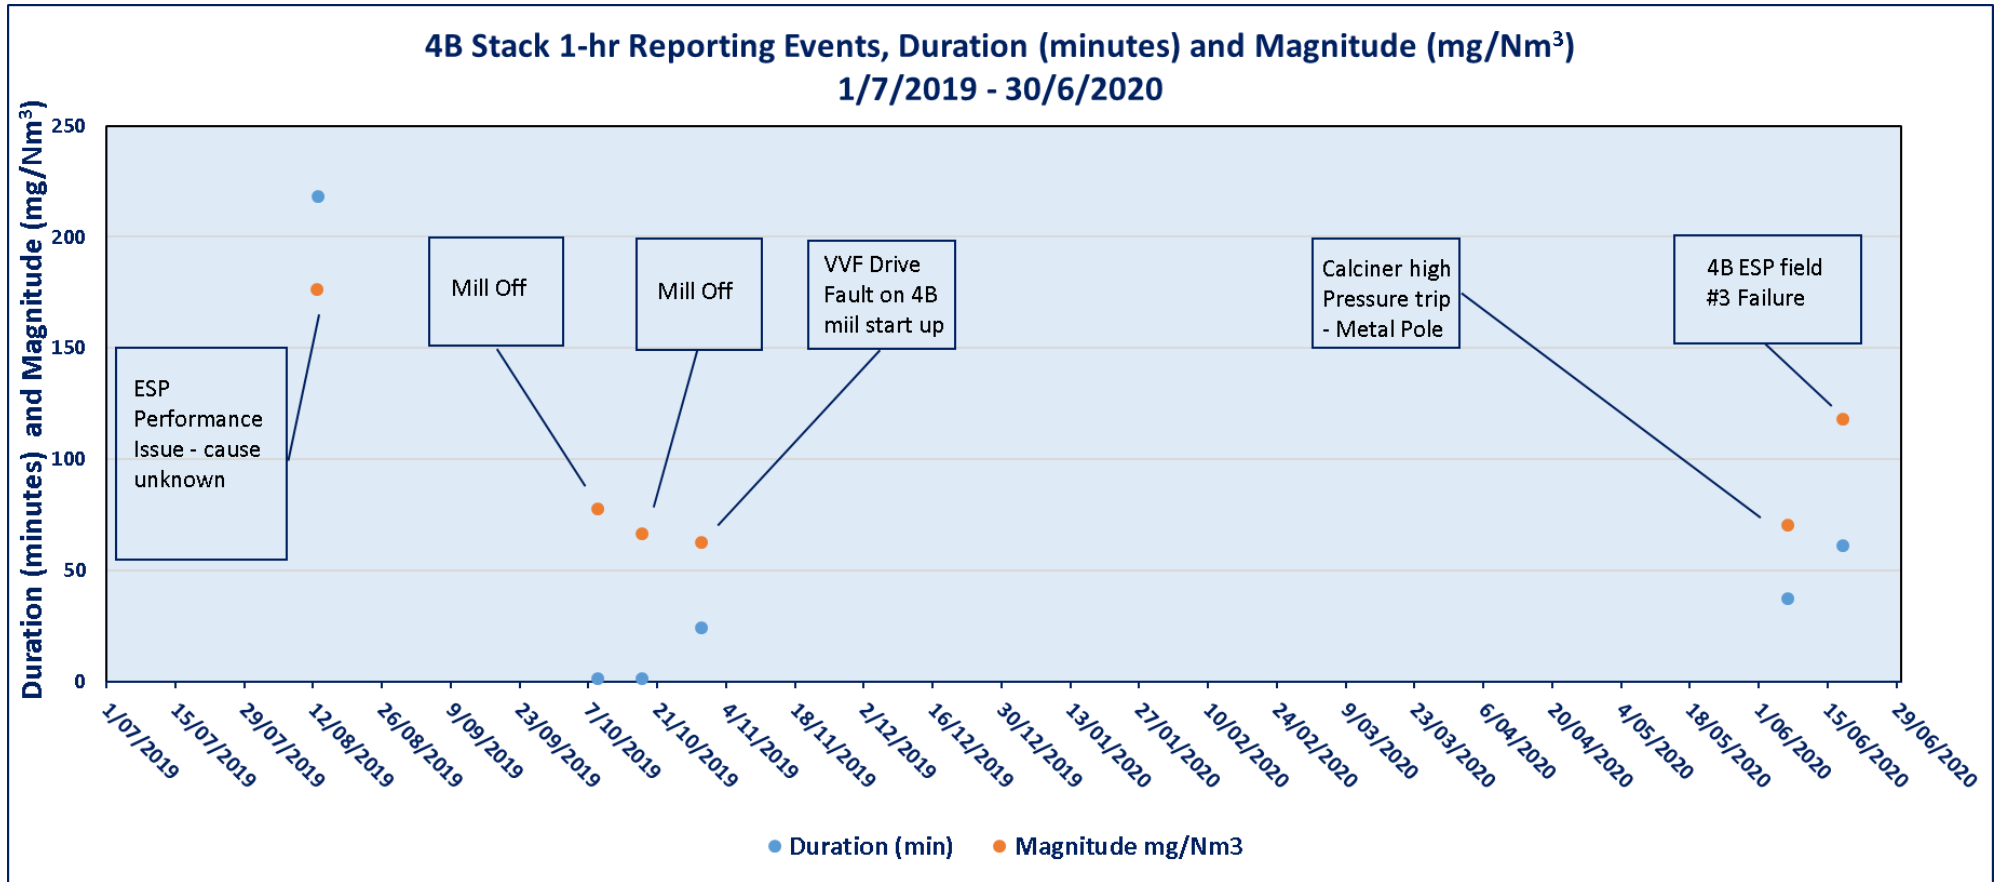
## 4B Stack:

Most 1-hr reporting events have a different root cause.  
1-hr reporting events were both process and equipment related.

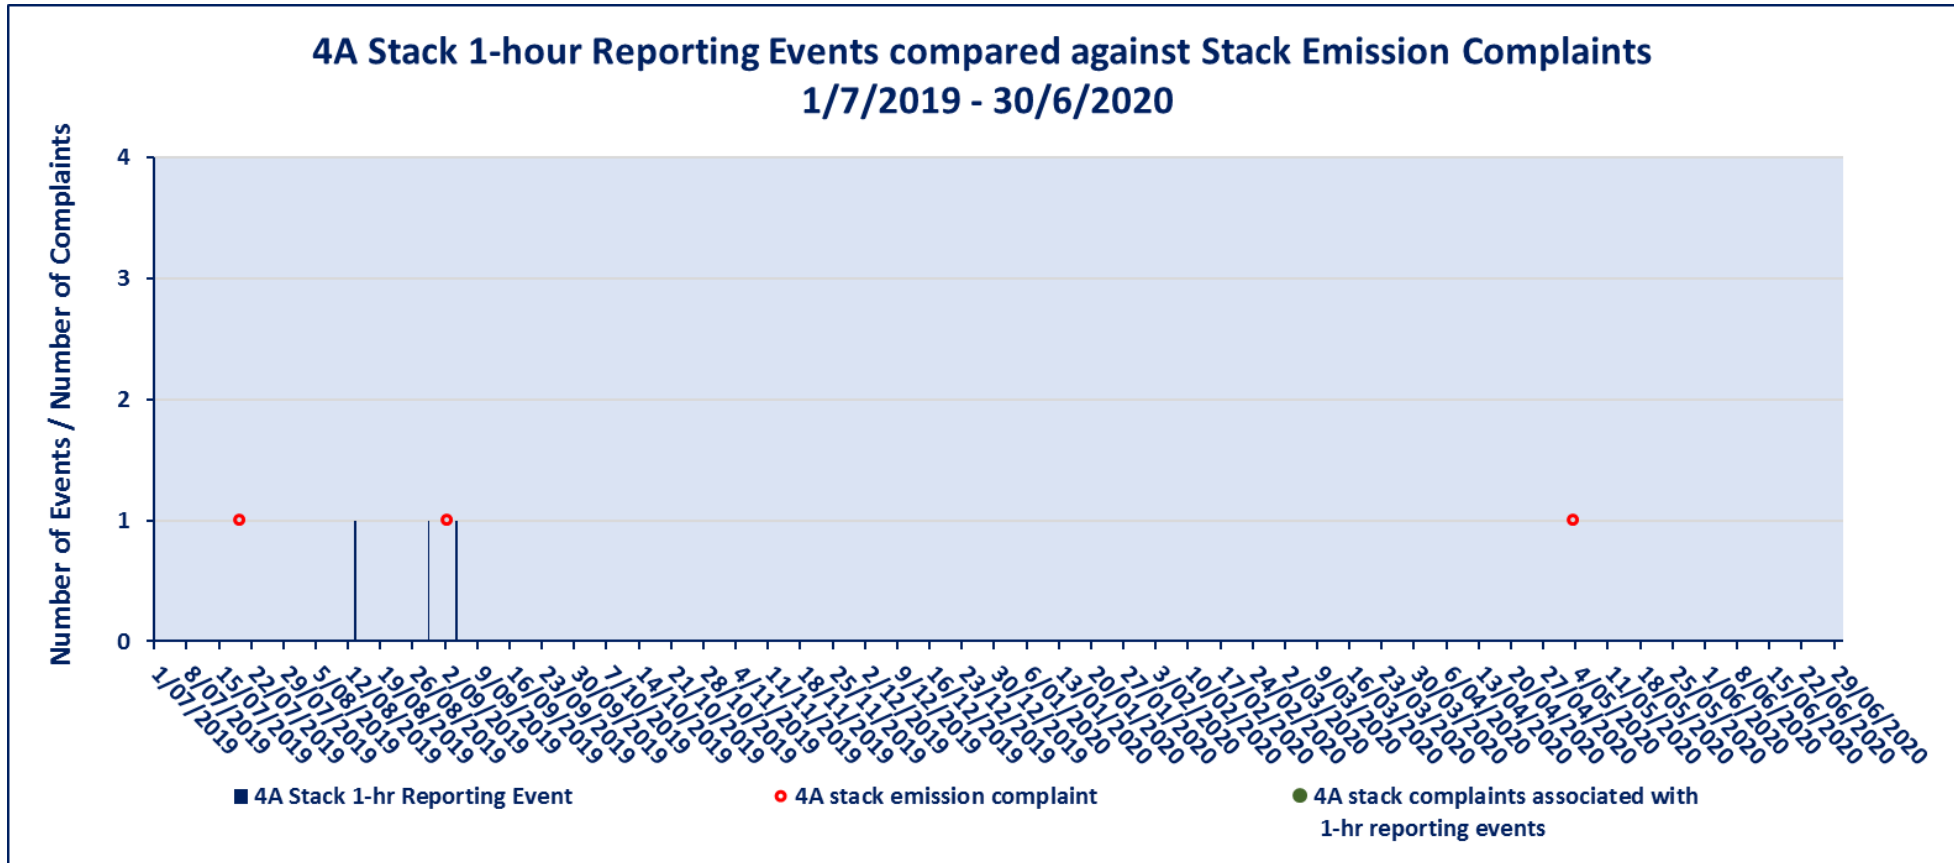
## 4A Stack:

Stack emission complaints did not coincide with 4A stack 1-hr reporting events.

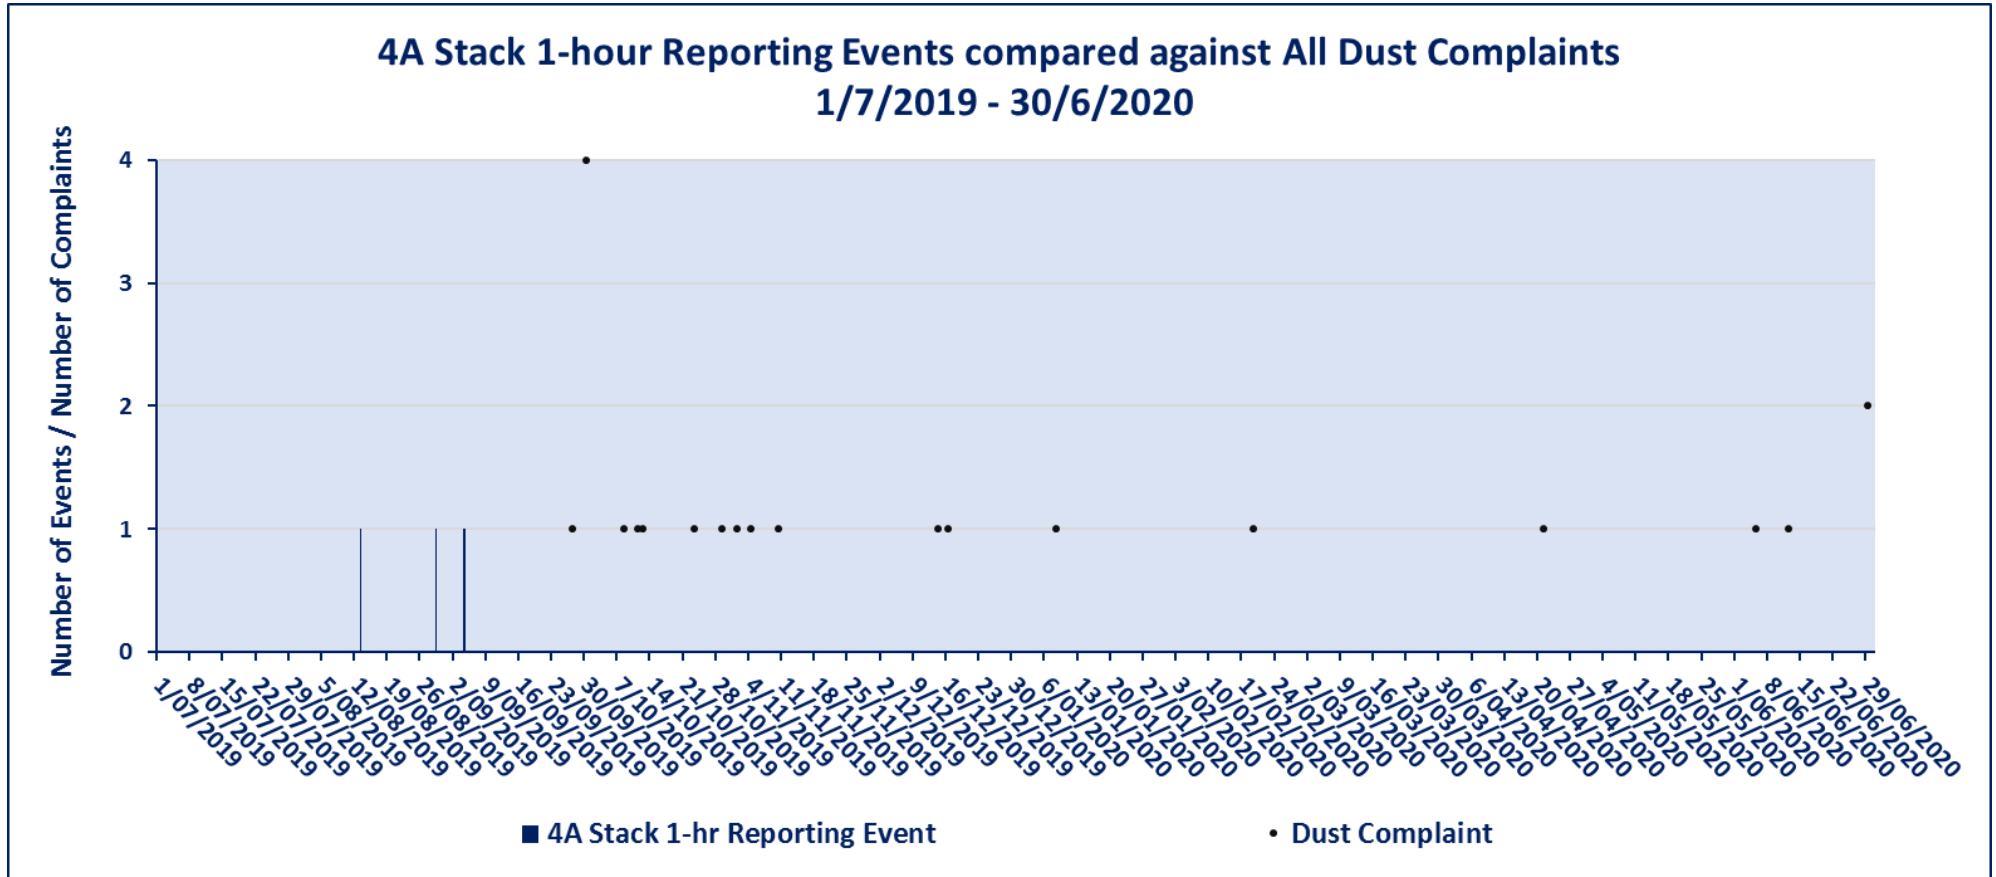
## 4A Stack:

Dust complaints did not coincide with 4A stack 1-hr reporting events, indicating dust complaints are not related to stack emissions.

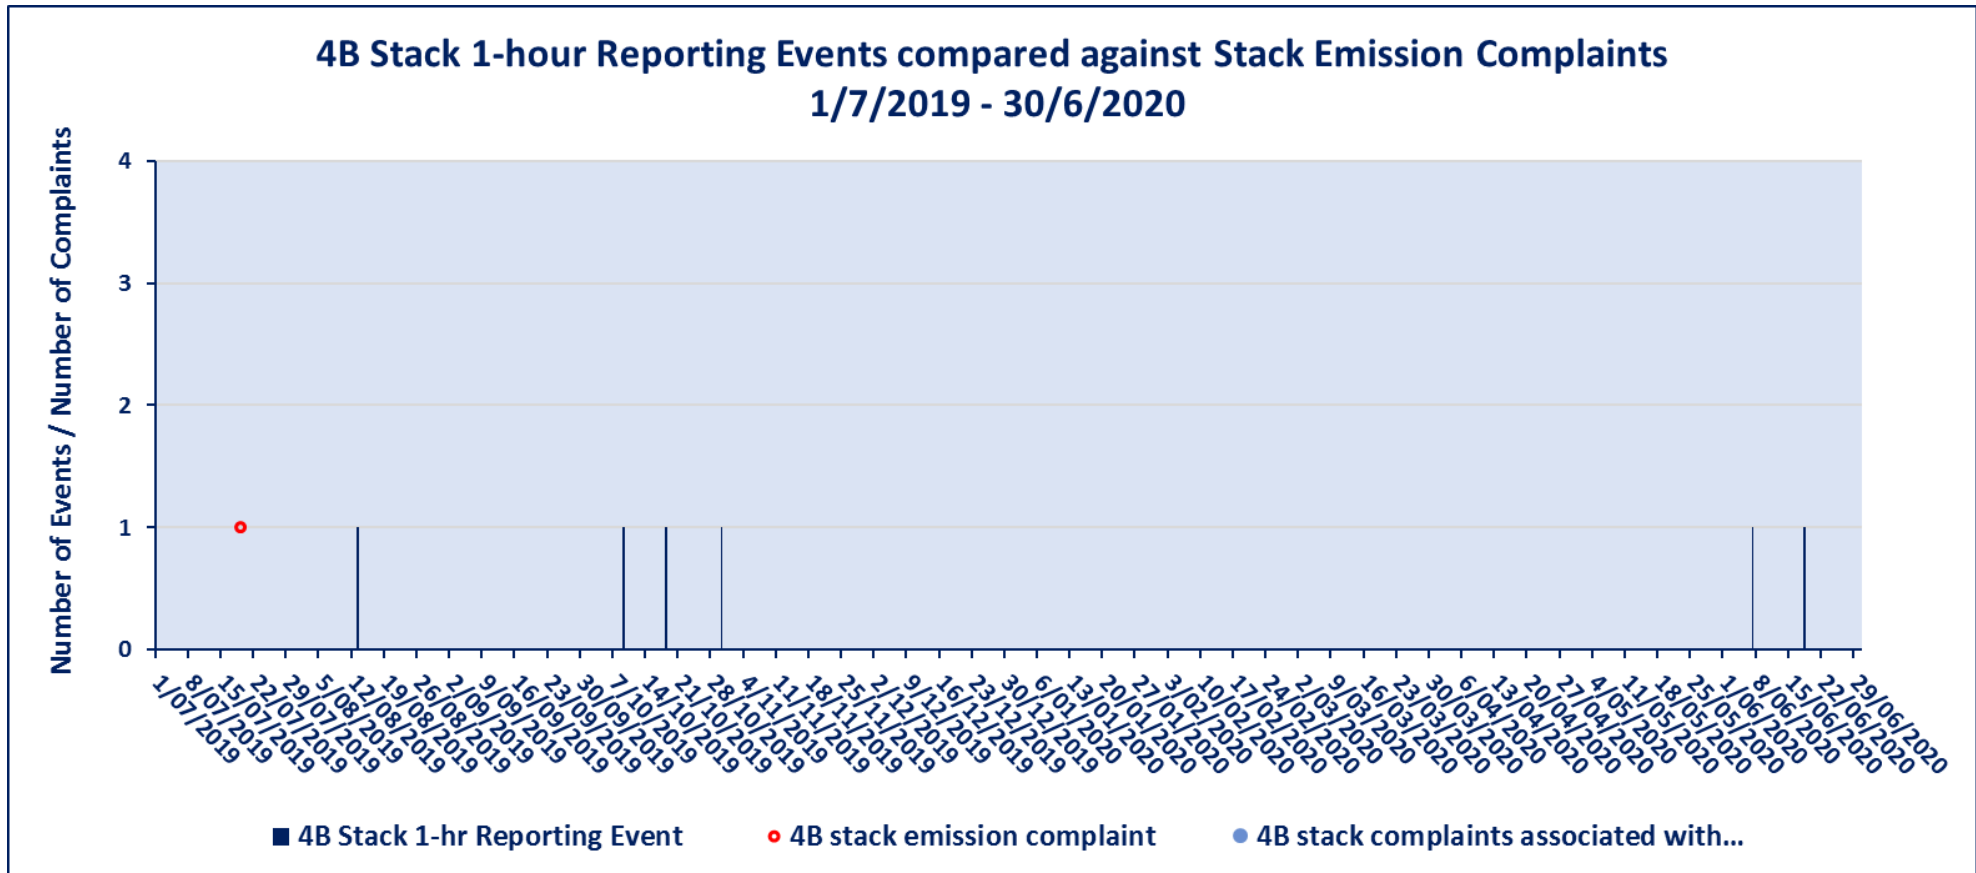
## 4B Stack:

Stack emission complaints did not coincide with 4B stack 1-hr reporting events.

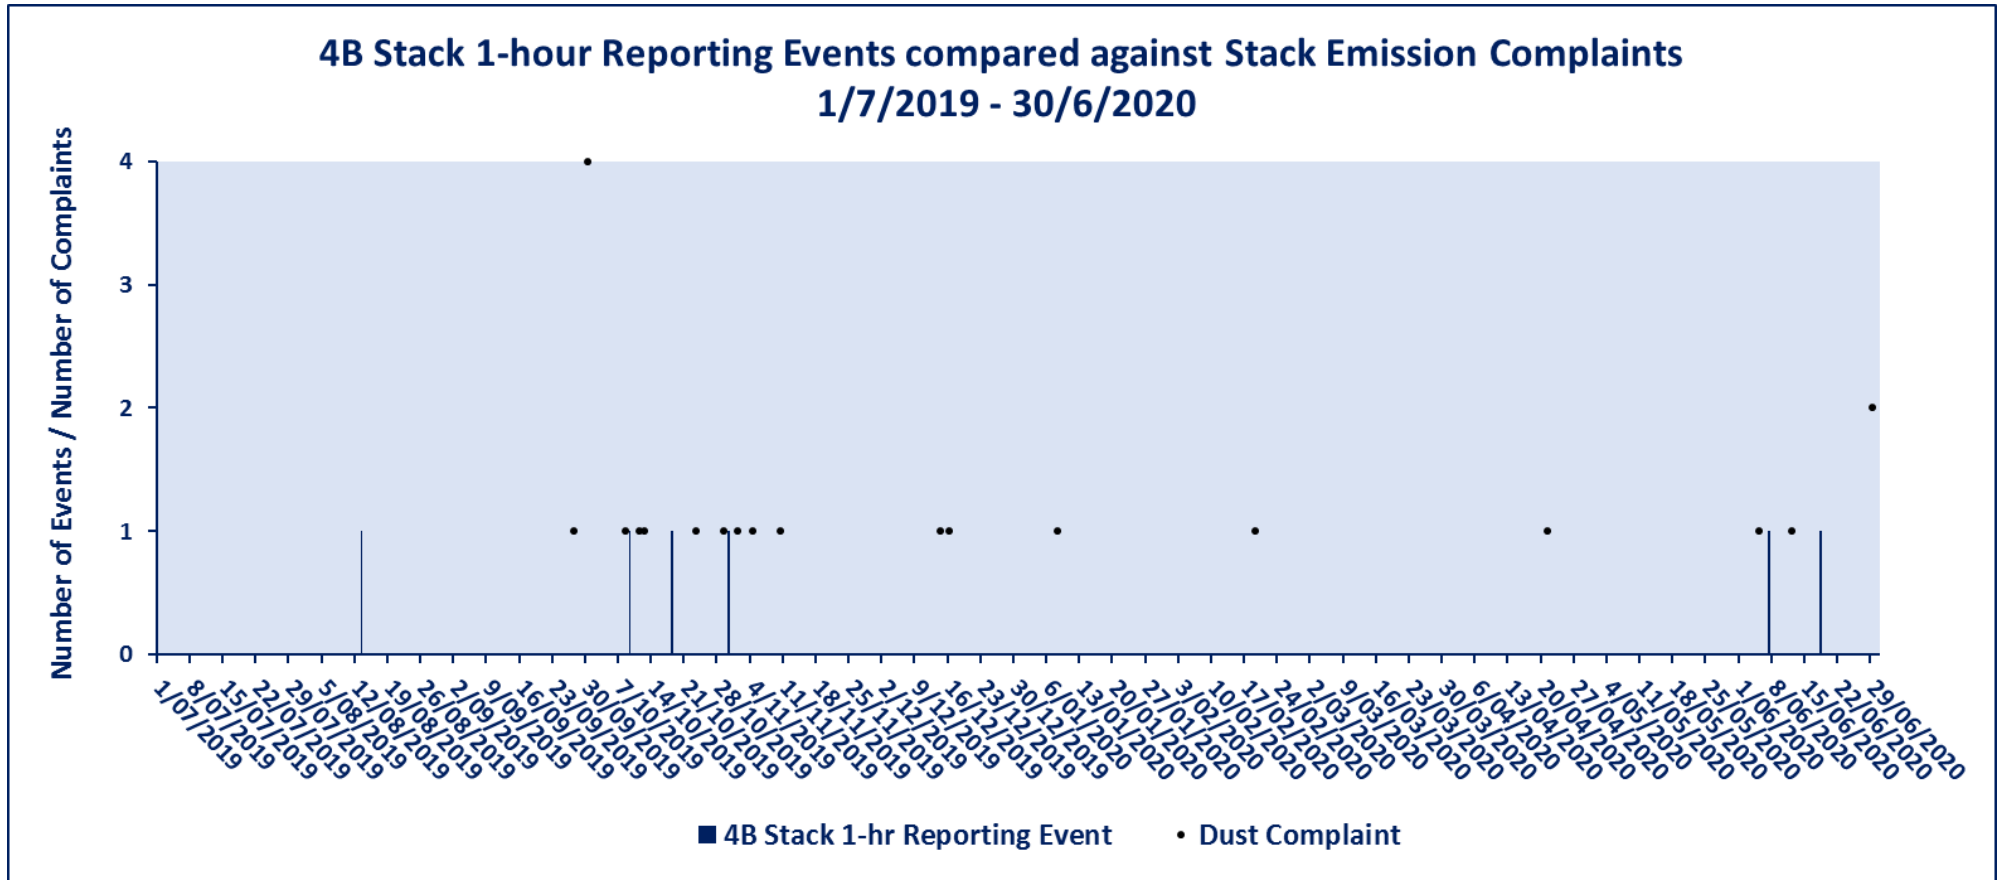
## 4B Stack:

Dust complaints did not coincide with 4B stack 1-hr reporting events, indicating dust complaints are not related to stack emissions.
