# Stack Particulate Management Plan

## Annual Stack Particulate Report

**Period: July 2018 – June 2019**

**Licensed site:** **Adelaide Brighton Cement, Birkenhead Works**

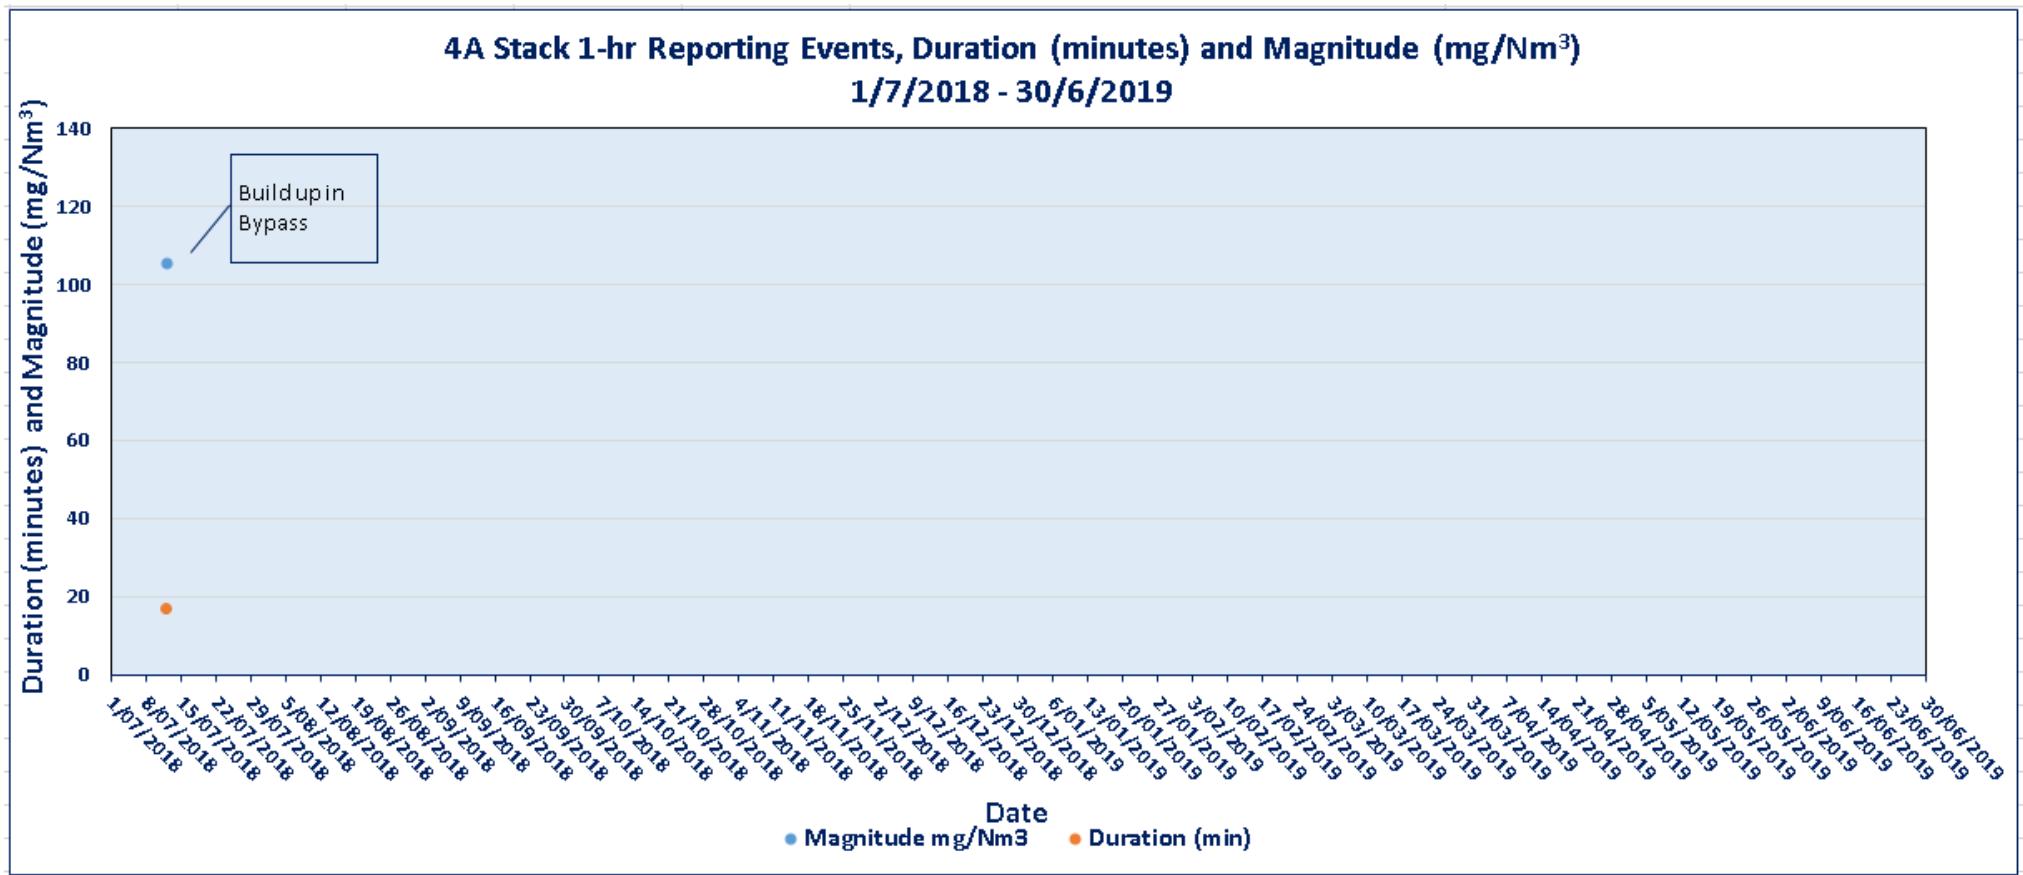
### 4A Stack:

There was only one, 1-hr Reporting event for the year.

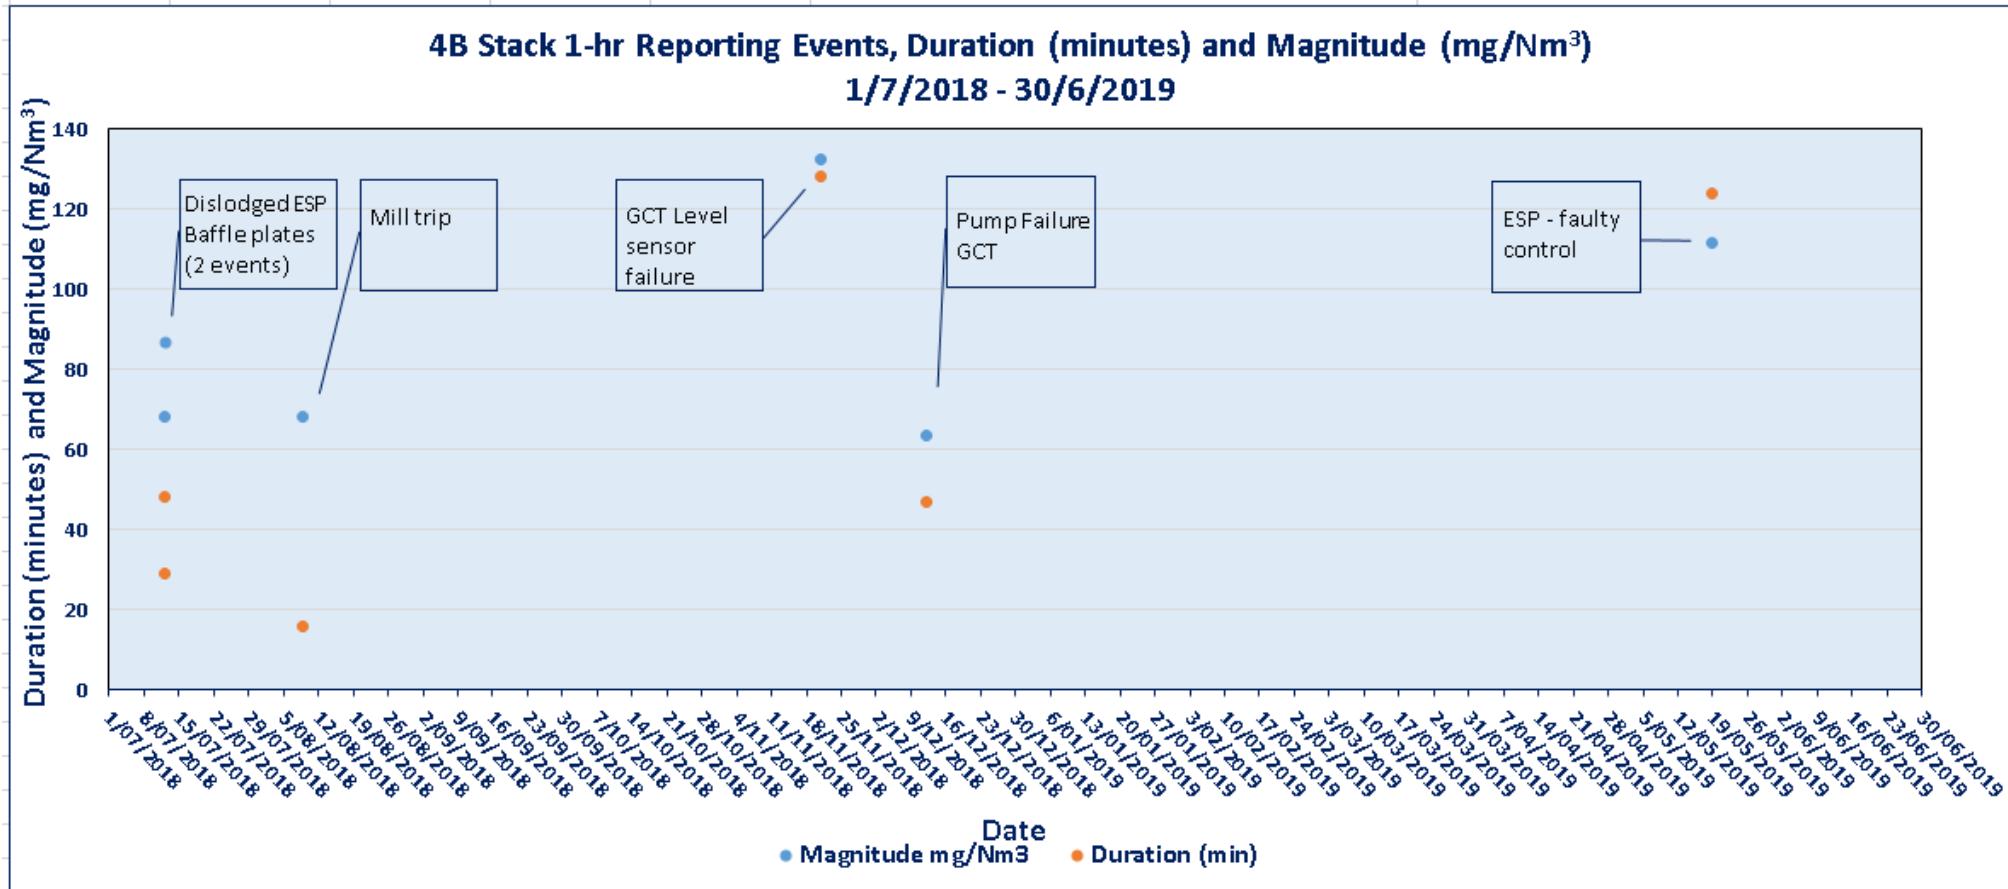
## 4B Stack:

Most 1-hr reporting events have a different root cause.

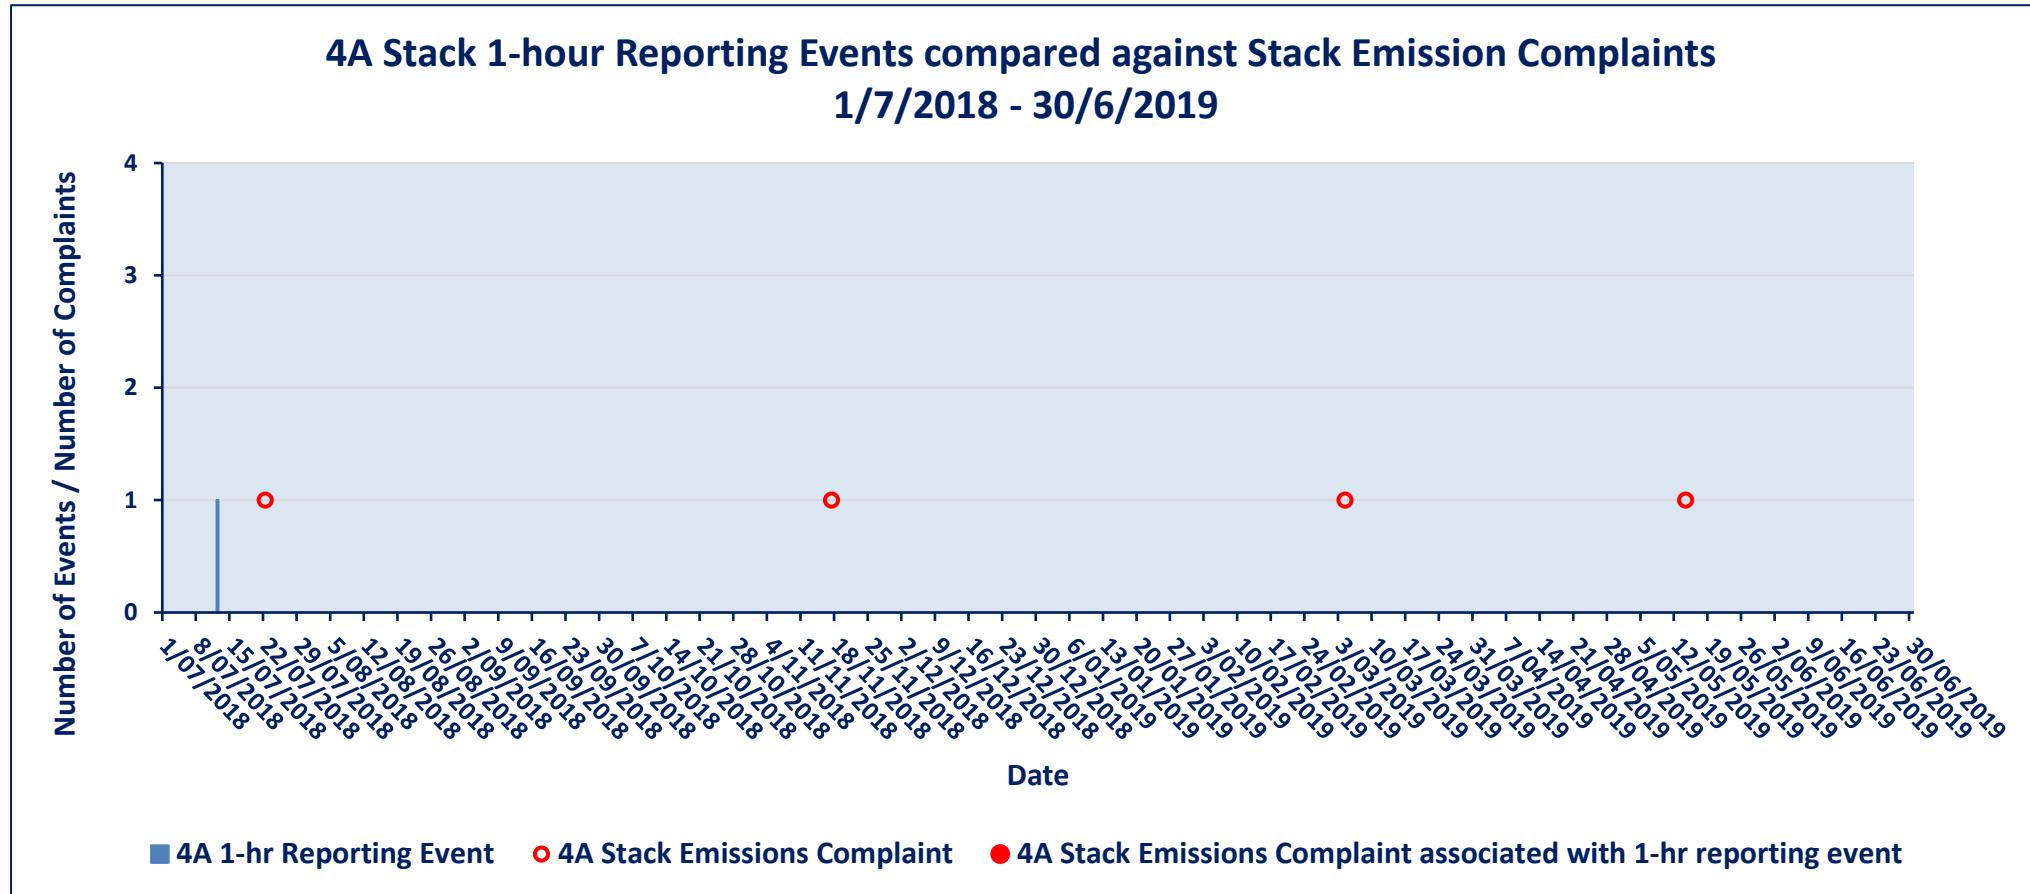
#### 4A Stack:

Stack emission complaints did not coincide with 4A stack 1-hr reporting events.

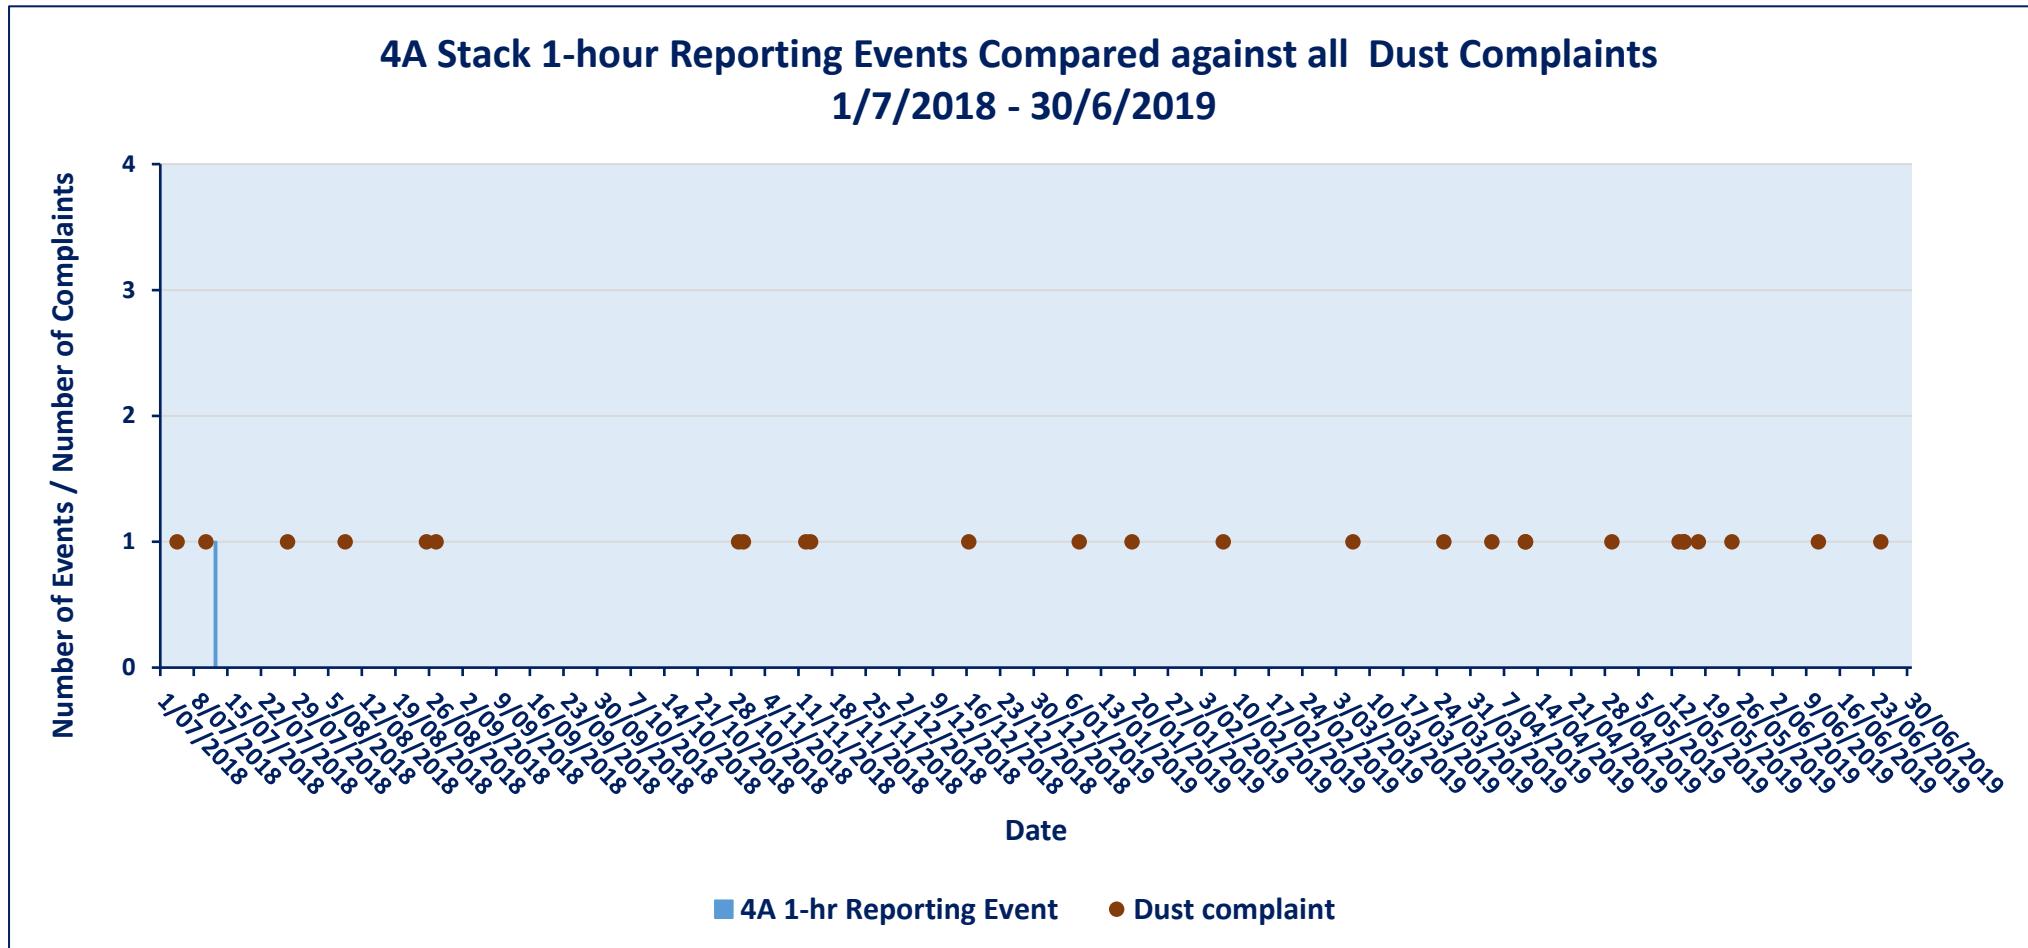
#### 4A Stack:

Dust complaints did not coincide with 4A stack 1-hr reporting events, indicating dust complaints are not related to stack emissions.

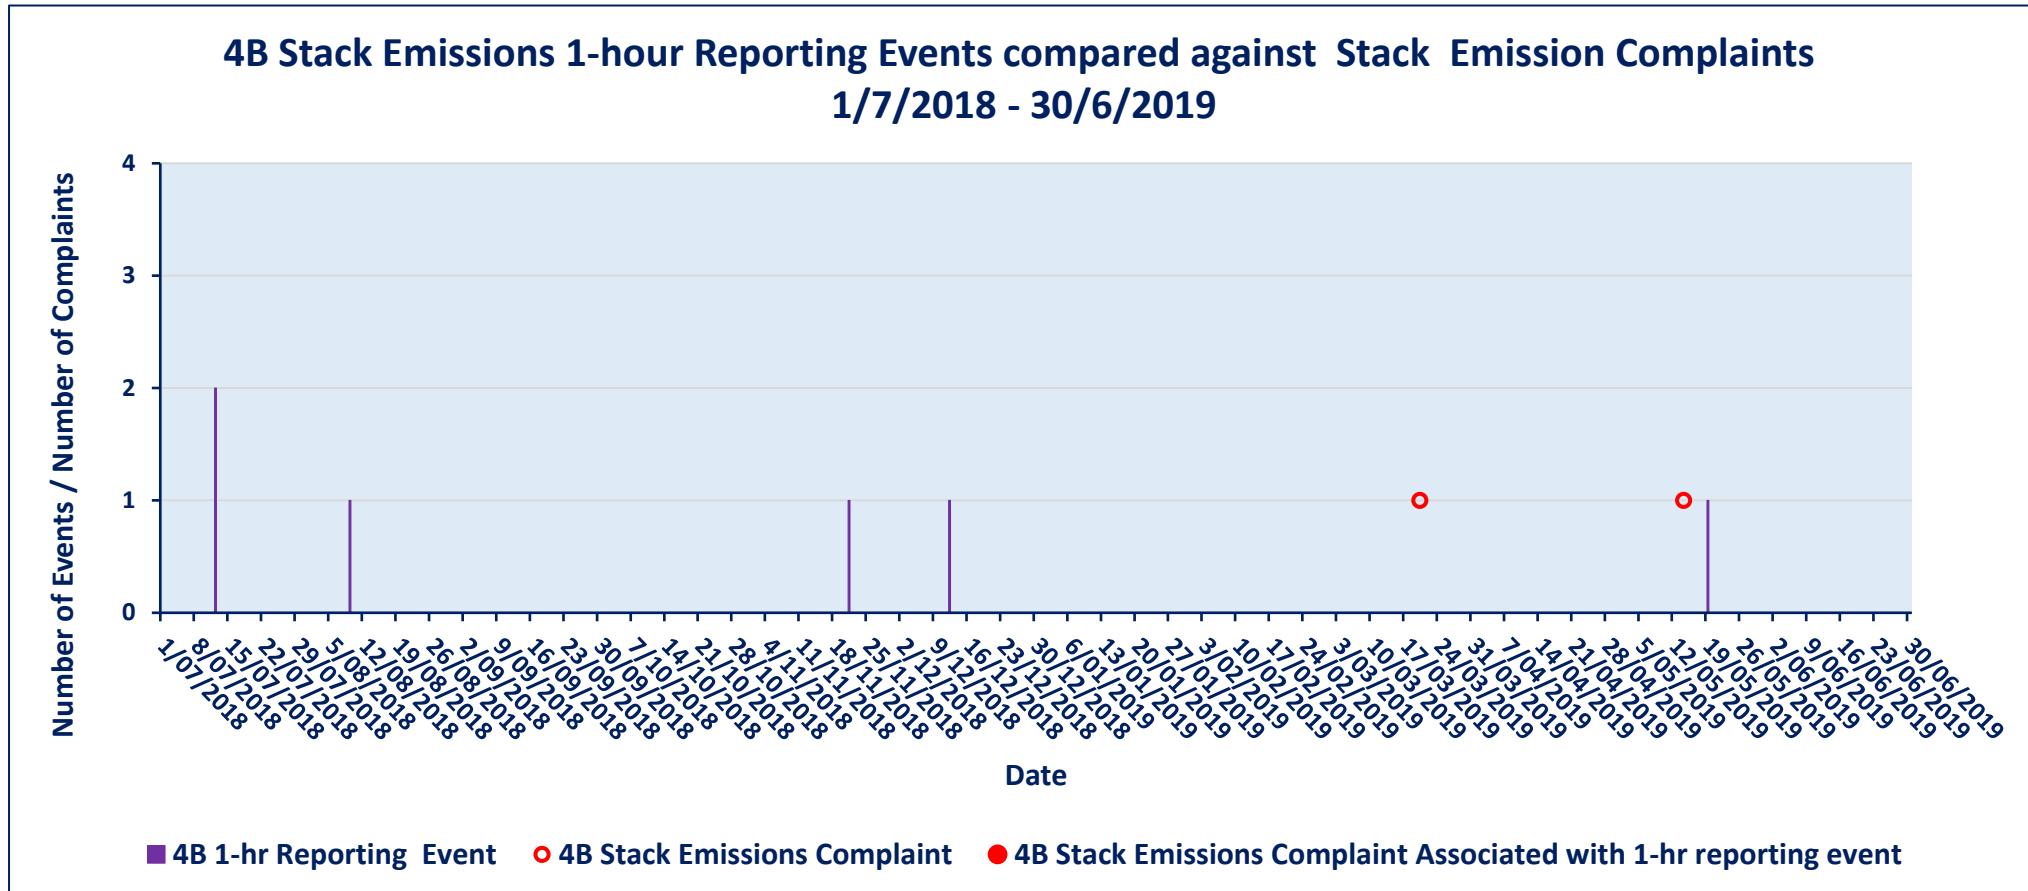
#### 4B Stack:

Stack emission complaints did not coincide with 4B stack 1-hr reporting events.

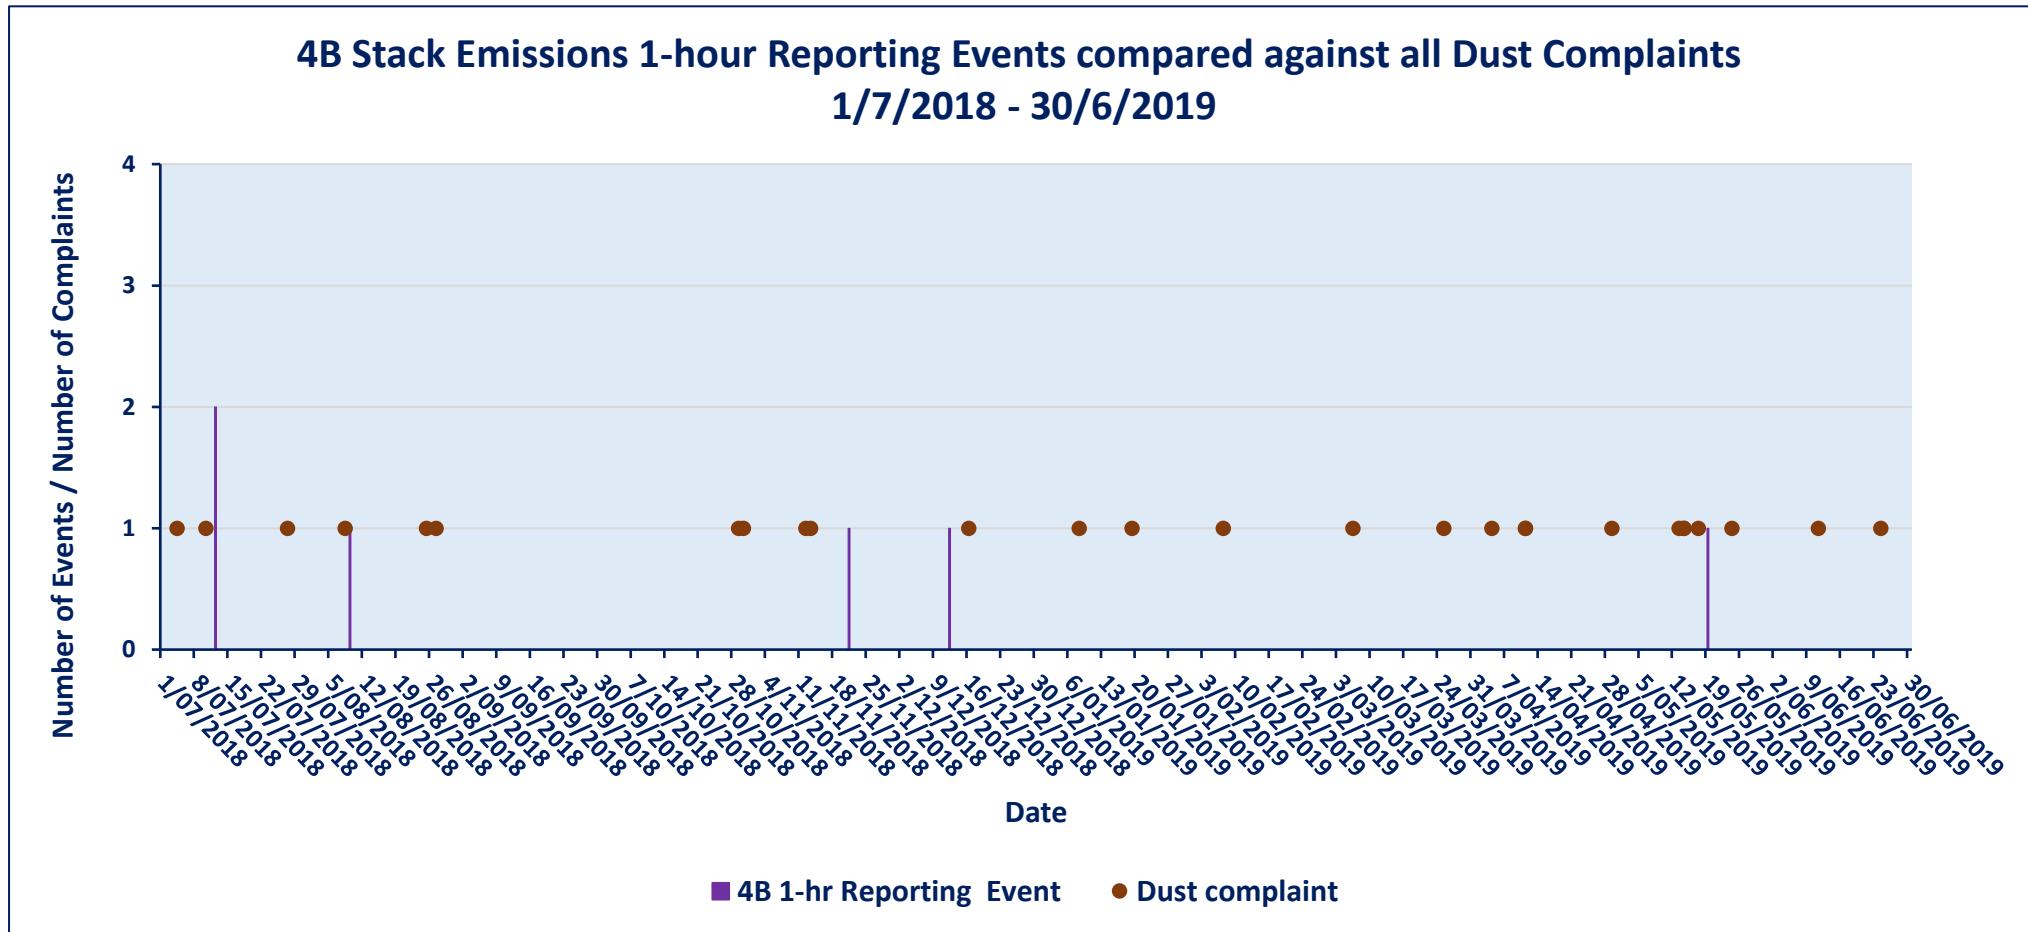
#### 4B Stack:

Dust complaints did not coincide with 4B stack 1-hr reporting events, indicating dust complaints are not related to stack emissions.
