Stack Particulate Management Plan Annual Stack Particulate Report

Period: 1 July 2020 – 30 June 2021

Licensed site: Adelaide Brighton Cement, Birkenhead Works

EPA Licence number: 1126

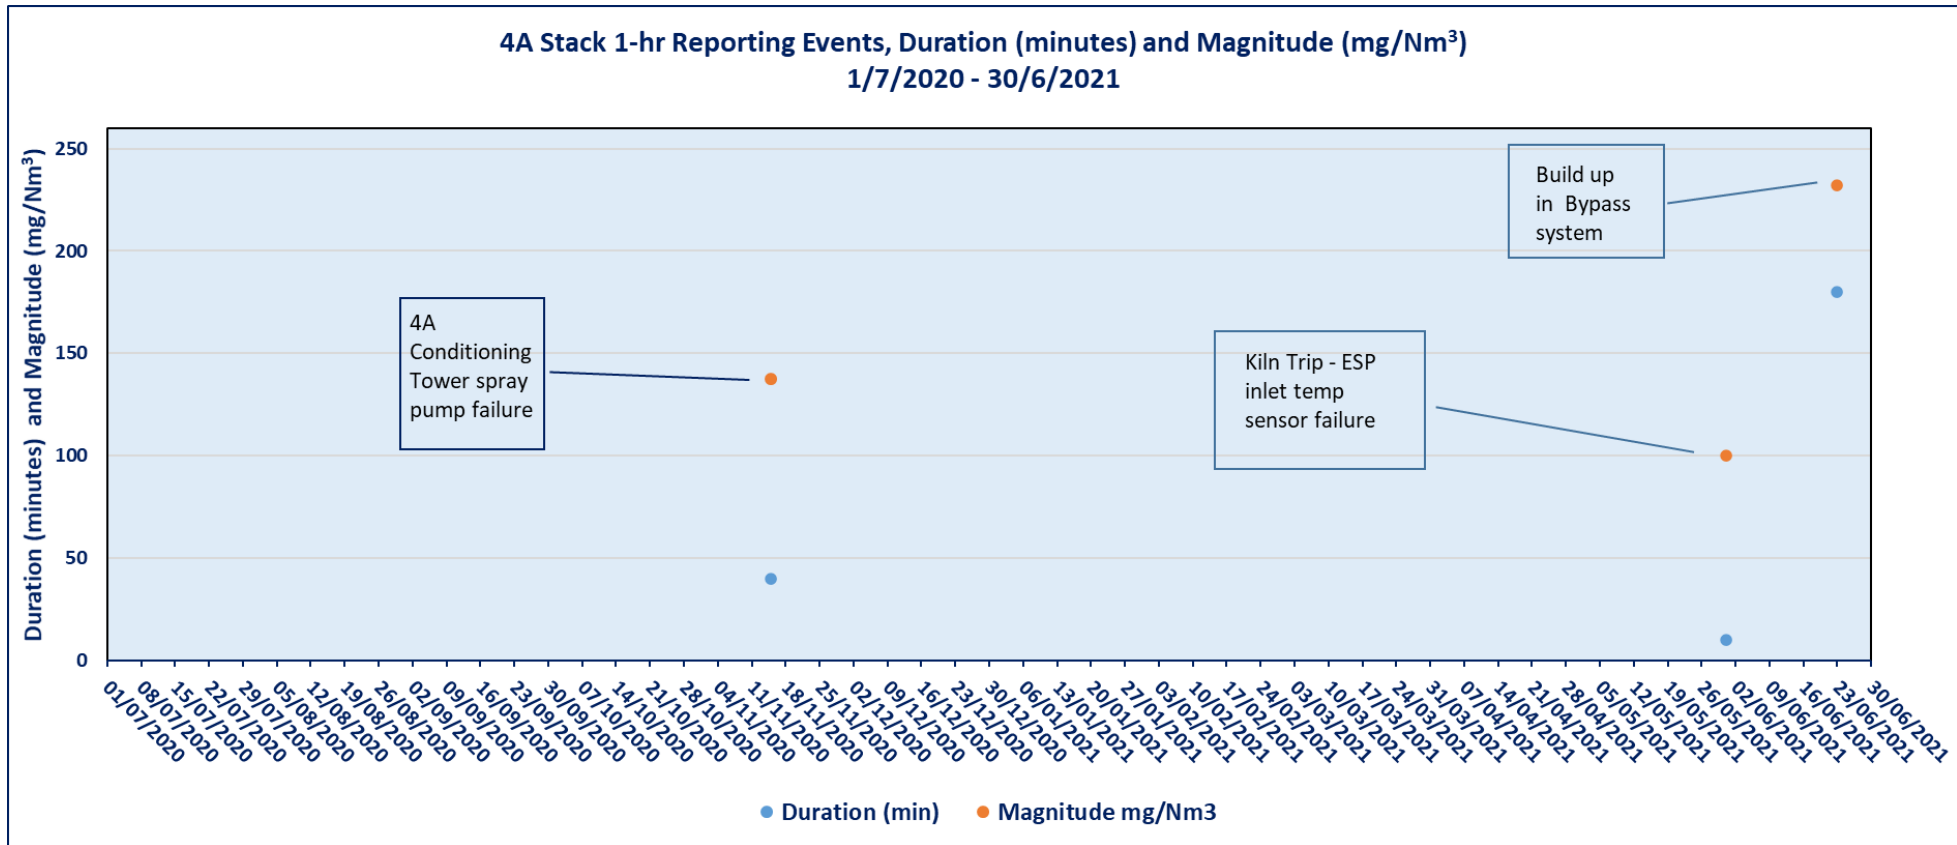
4A Stack:

There were 3, 1-hr reporting events for the year.

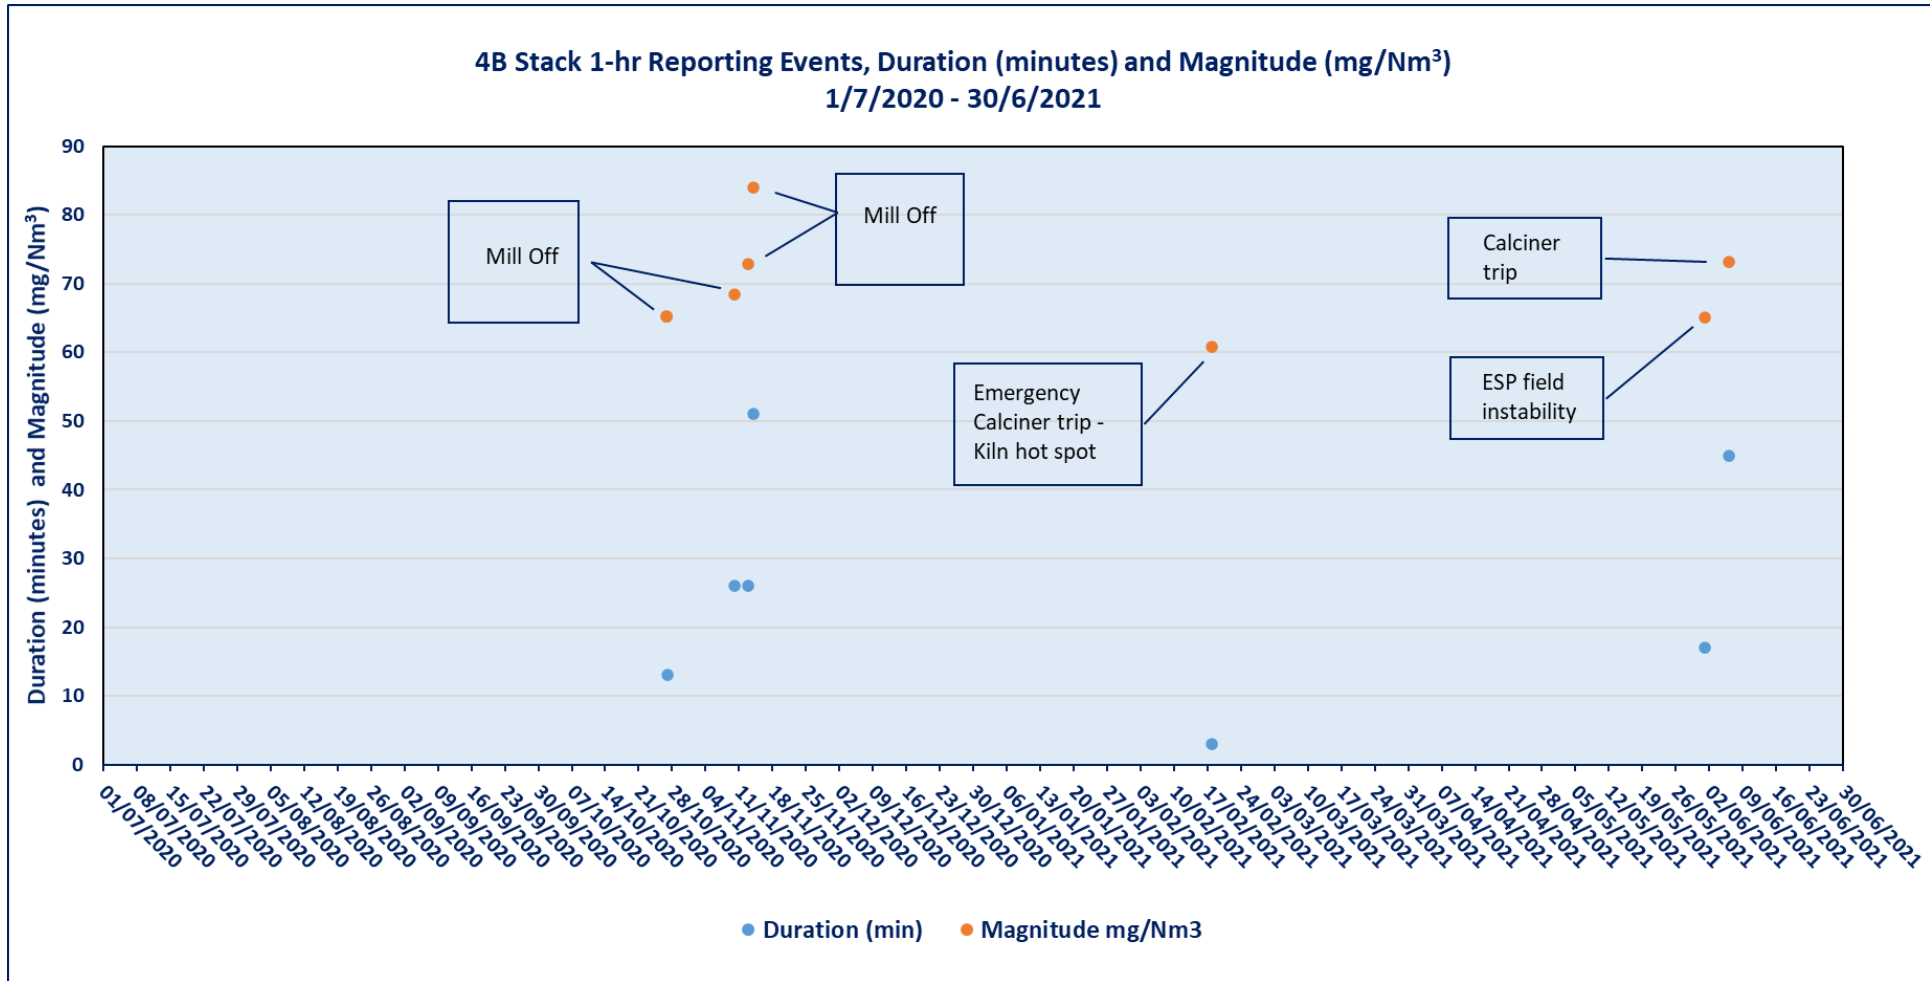
4B Stack:

There were 7, 1-hr reporting events for the year.

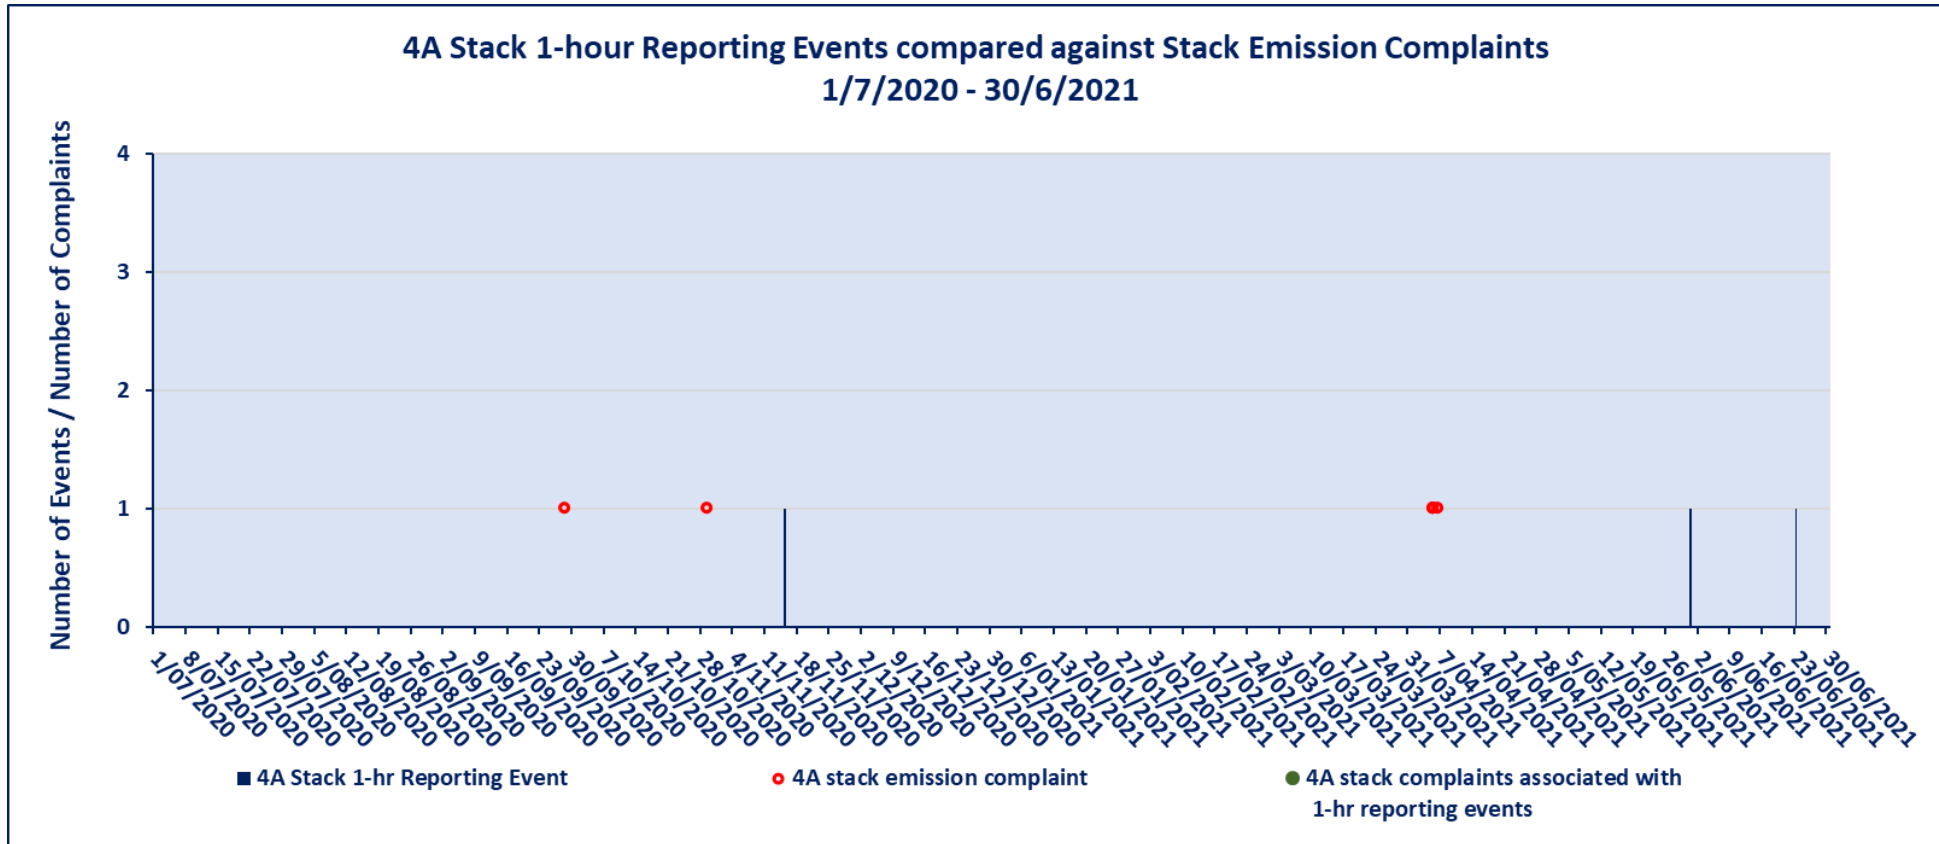
4A Stack:

Stack emission complaints did not coincide with 4A stack 1-hr reporting events.

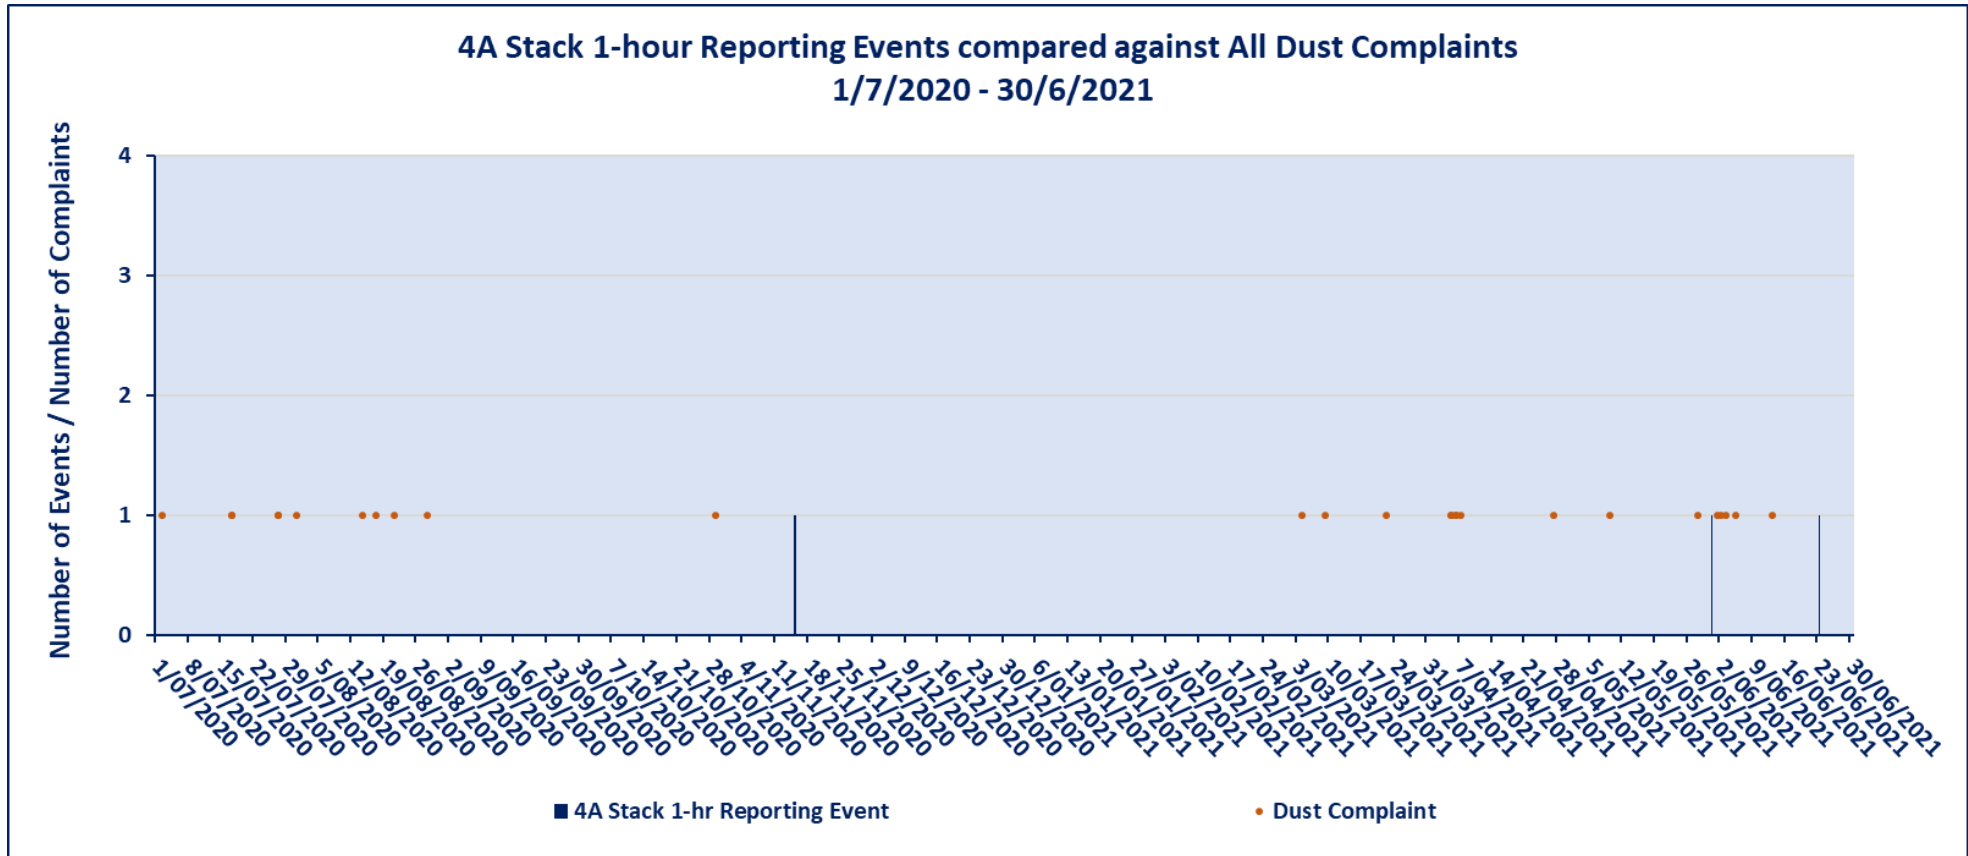
4A Stack:

Dust complaints did not coincide with 4A stack 1-hr reporting events, indicating dust complaints are not related to stack emissions.

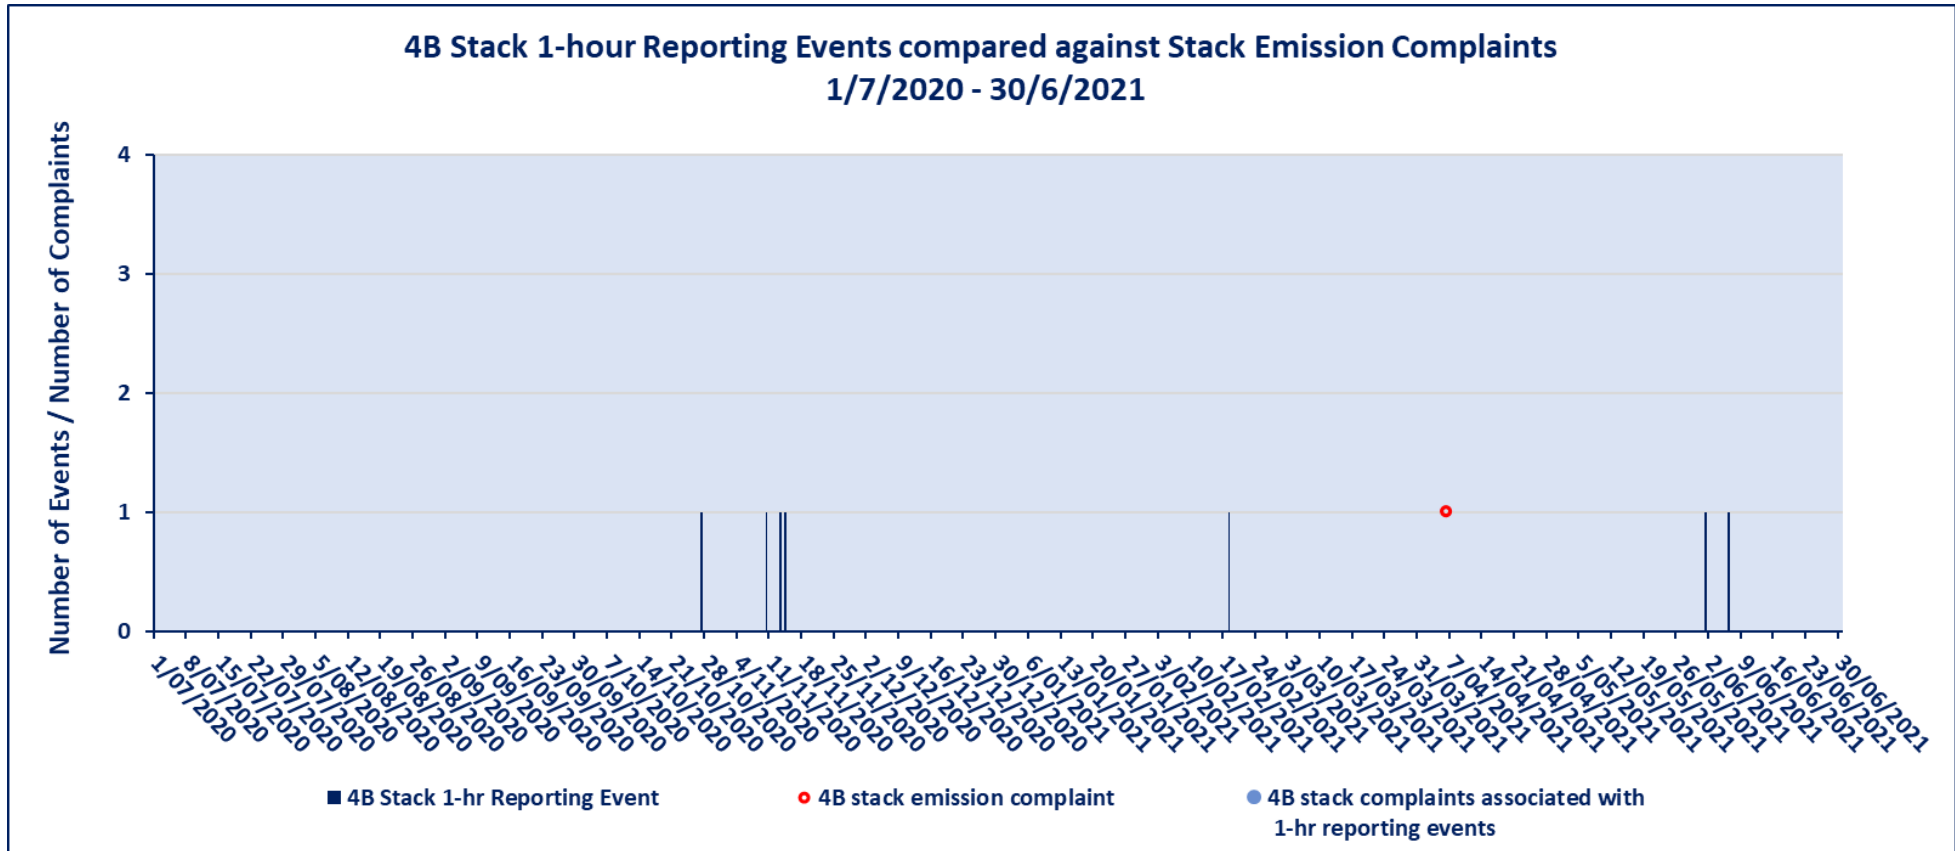
4B Stack:

Stack emission complaints did not coincide with 4B stack 1-hr reporting events.

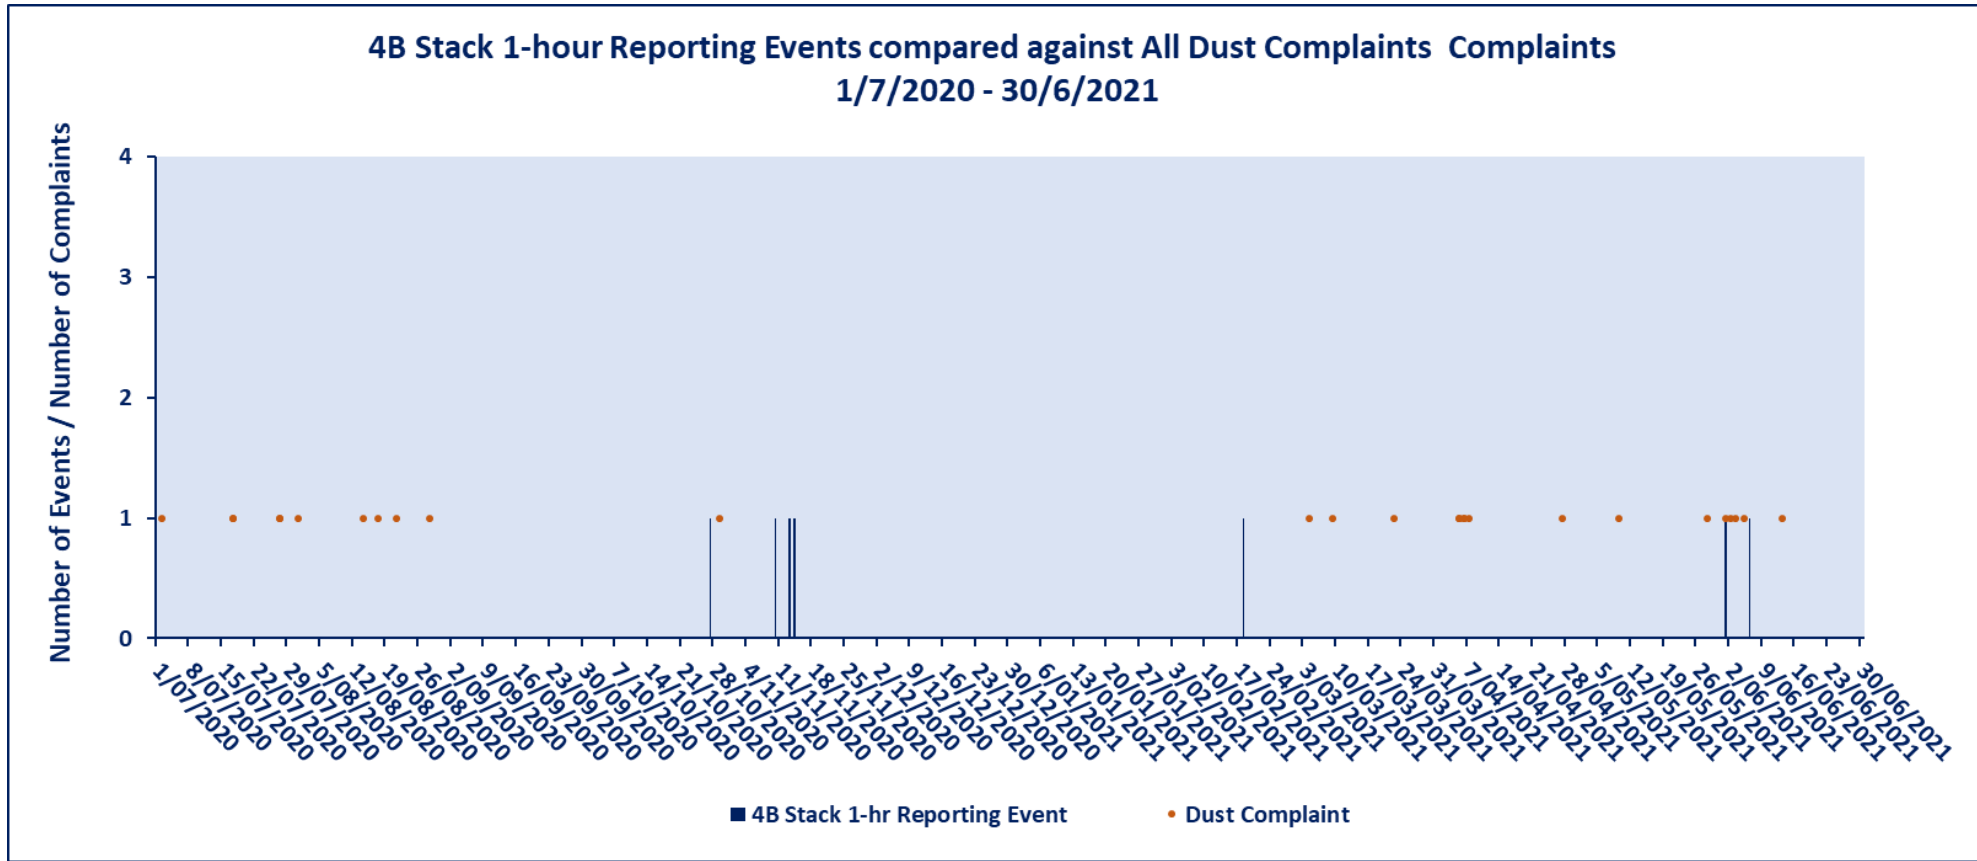
4B Stack:

Dust complaints did not coincide with 4B stack 1-hr reporting events, indicating dust complaints are not related to stack emissions.
