## QUARTERLY NOISE MANAGEMENT REPORT FOR BIRKENHEAD WORKS

**COMPLIANCE DATE: 15/05/2022– Quarter 1 2022**  
**EPA Licence 1126: Noise Management Plan (U-787)**

**Licensed site: Adelaide Brighton Cement, Birkenhead Works**

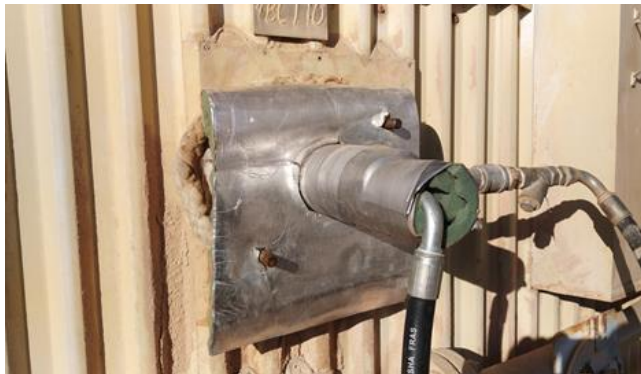
4B Conditioning Tower sprays

The intermittent and variable nature of this noise source makes it difficult to find an effective solution.

This solution appeared to be effective until recurrence of complaints from 30/10/2021.

Pyrotech Soundlag 4525C installed on the spray nozzle pipework

Various acoustic treatments have been installed on the spray nozzles. The last treatment Pyrotech Soundlag 4525C (a highly flexible foam-based composite acoustic pipe lagging product), was installed on the spray nozzle pipework in January 2021.

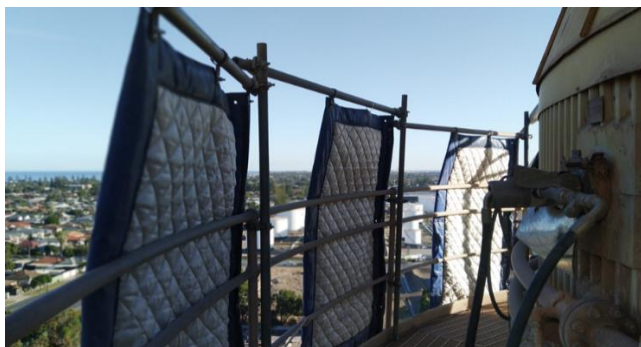
Noise abatement curtains placed in front of spray nozzles.

ABC is trialling noise abatement curtains in addition to the spray nozzle insulation.

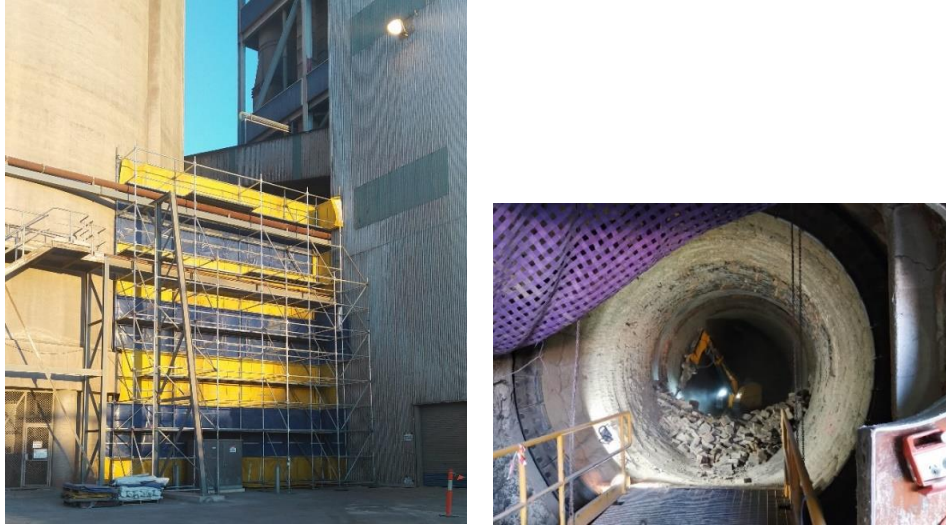
Photo of noise attenuation barrier and pneumatic breaker in the kiln

- Remote controlled pneumatic breaker (Brokk) – allows for better control of the activity
- A 14m high noise barrier was installed
- Noisiest activities scheduled during the daytime period and stopped at 10 pm
- Daily team briefing / HSE toolbox meetings including
