# **Stack Particulate Management Plan Annual Stack Particulate Report**

**Period: 1 July 2021 – 30 June 2022**

**Licensed site: Adelaide Brighton Cement, Birkenhead Works**

**EPA Licence number: 1126**

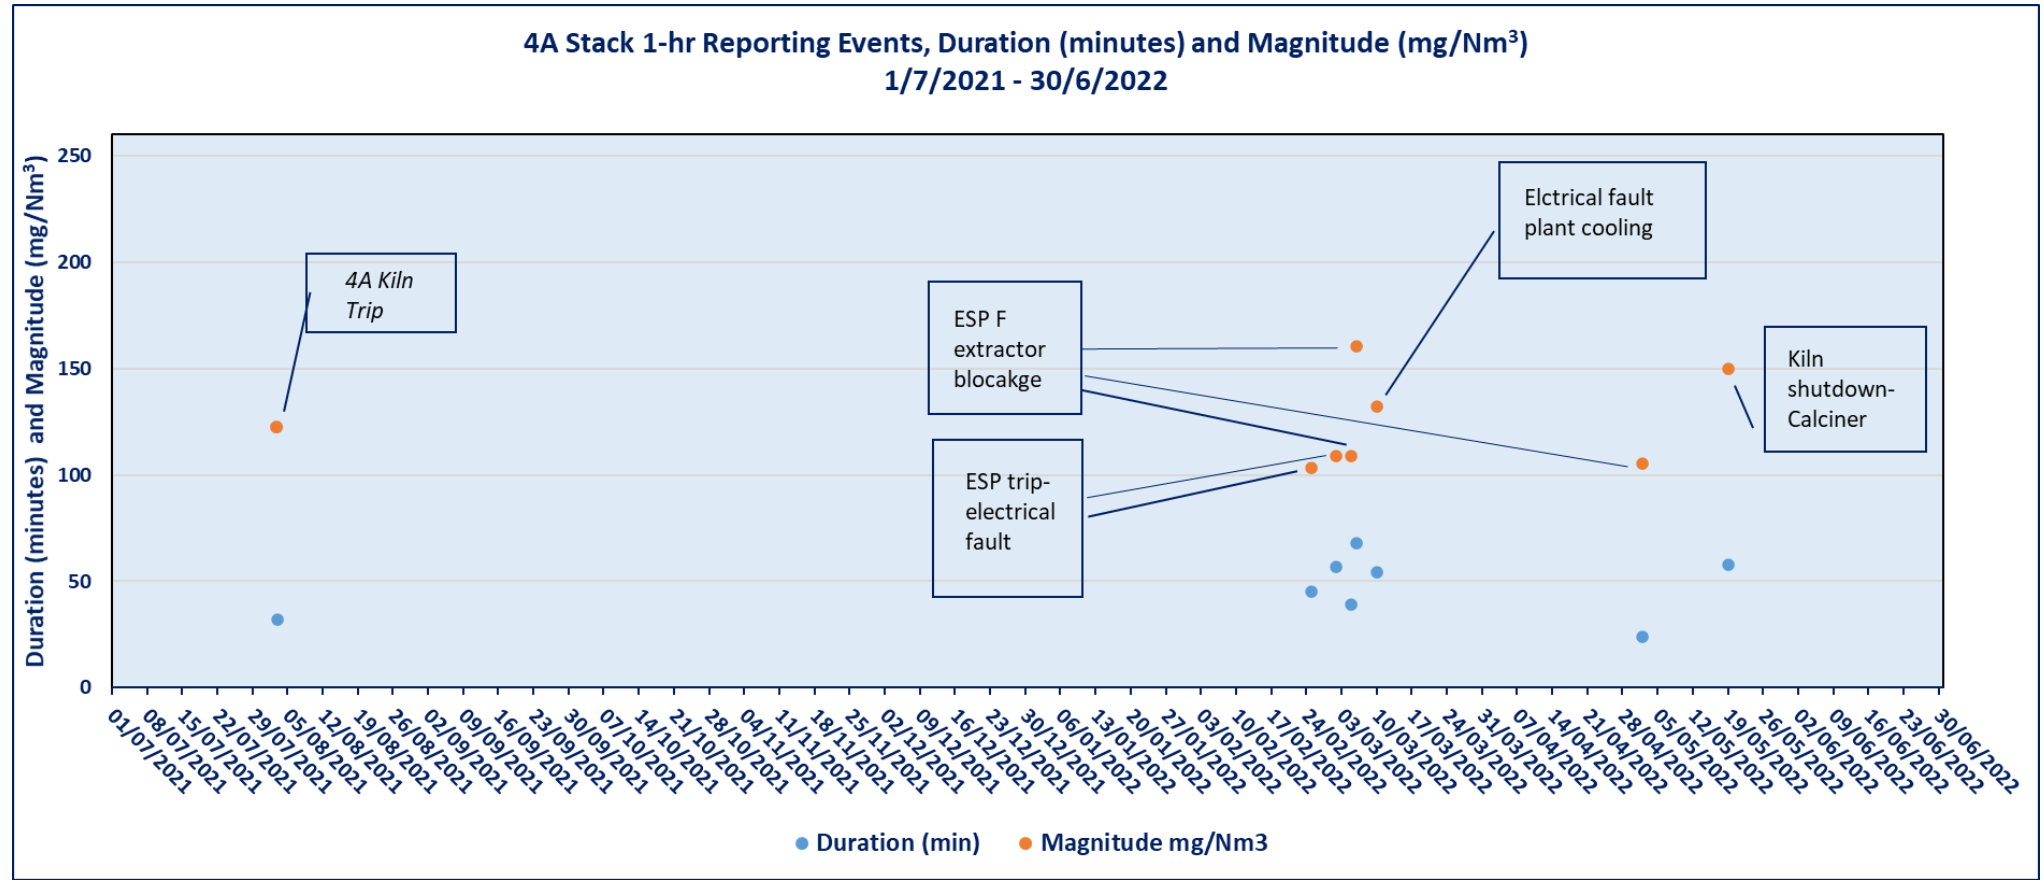
4A Stack:

There were 8, 1-hr reporting events for the year.

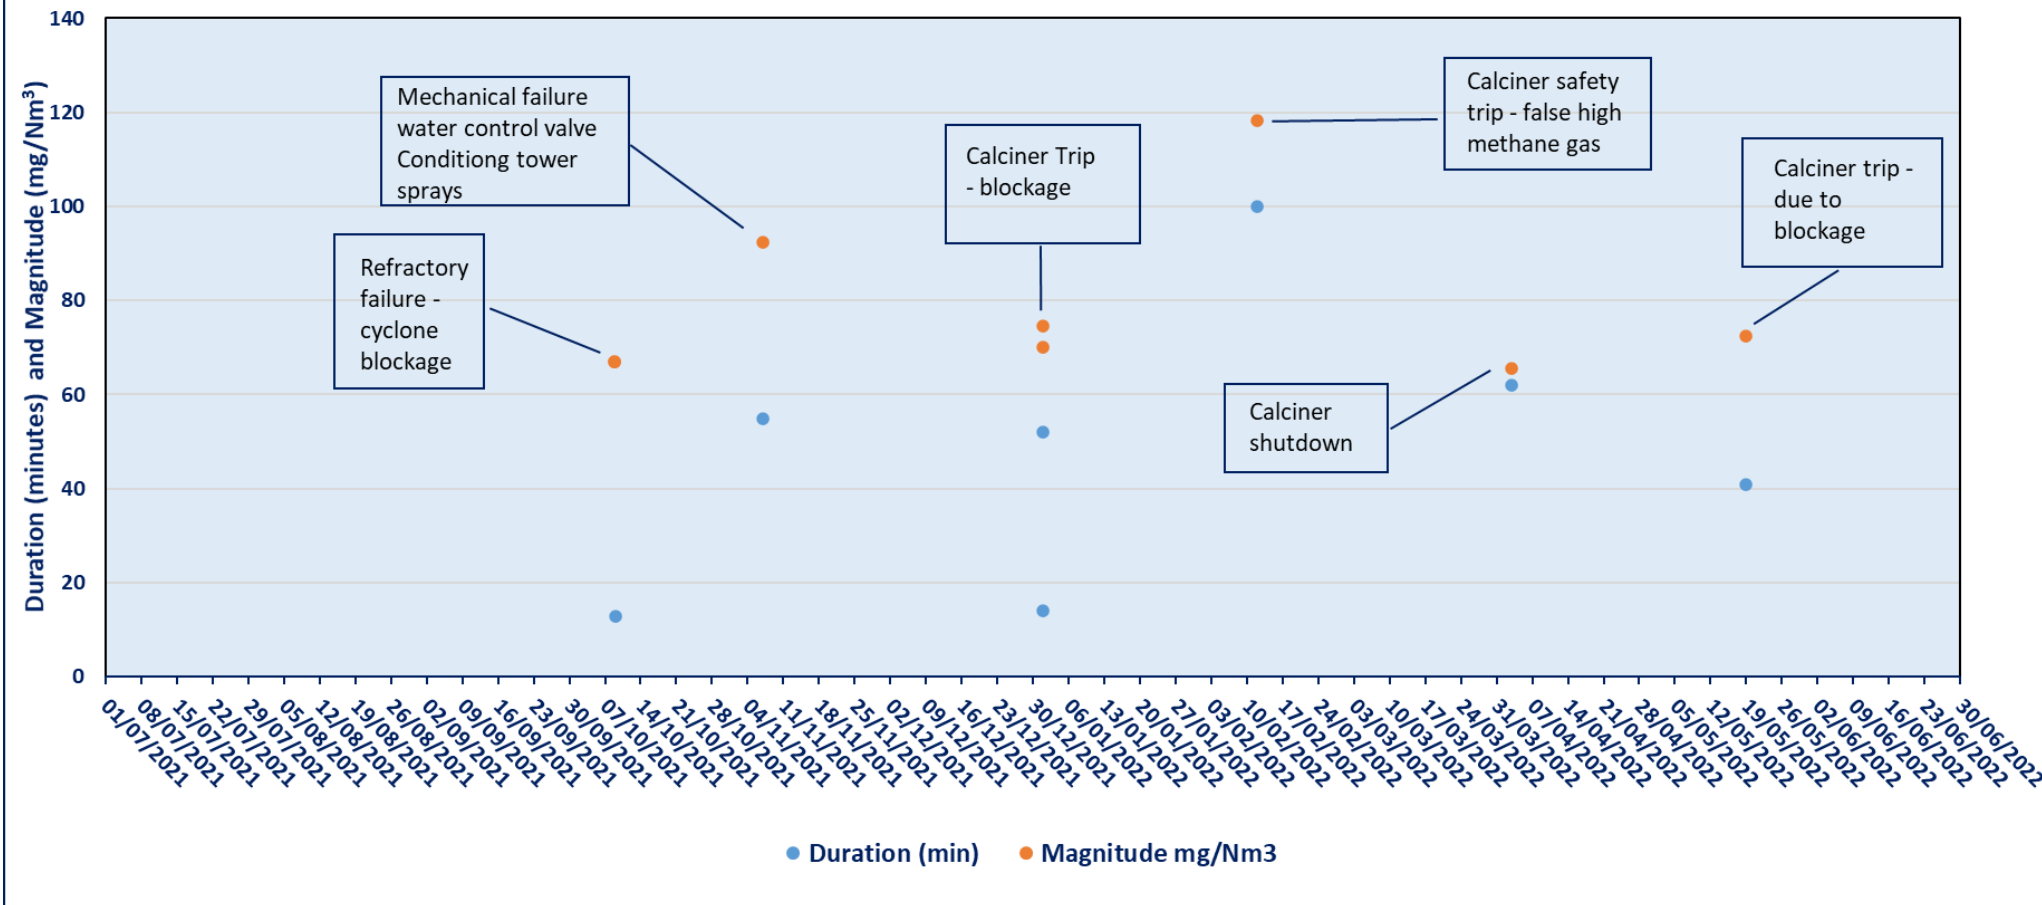
4B Stack 1-hr Reporting Events, Duration (minutes) and Magnitude (mg/Nm<sup>3</sup>)  
1/7/2021 - 30/6/2022

There were 7, 1-hr reporting events for the year.

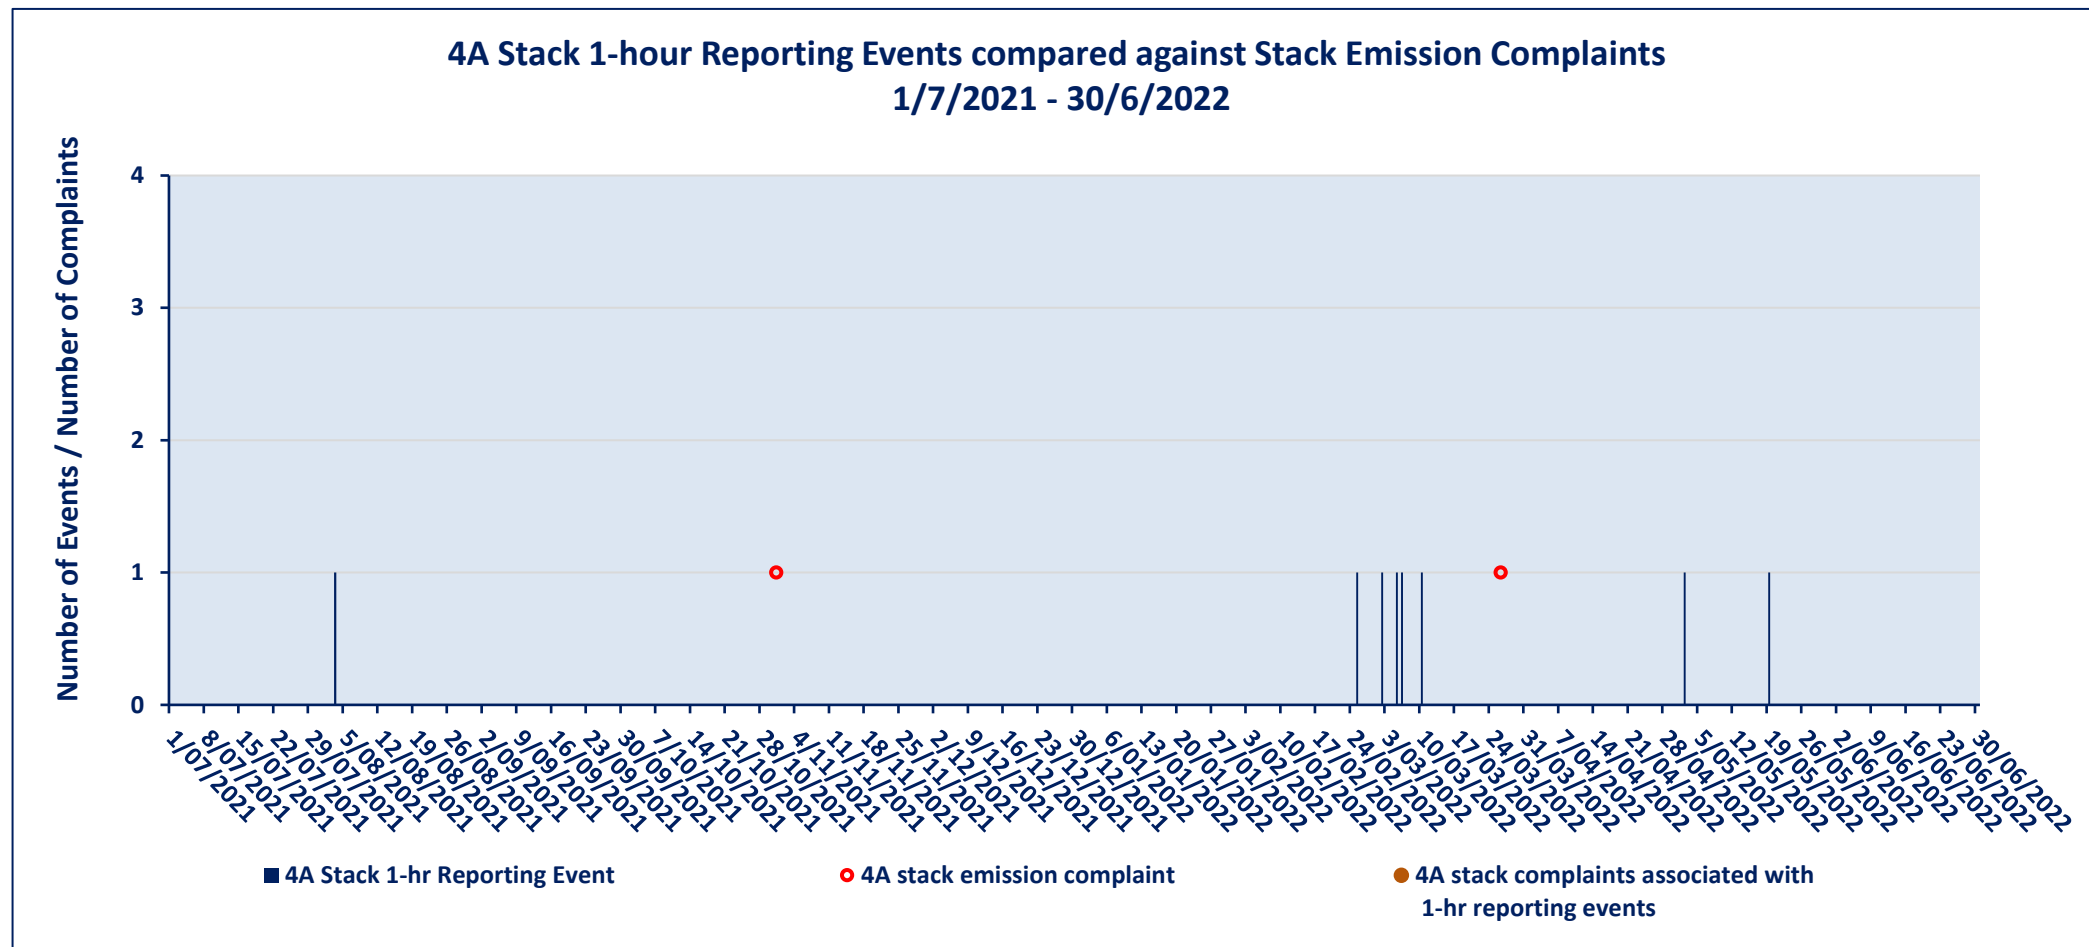
**4A Stack:**

Stack emission complaints did not coincide with 4A stack 1-hr reporting events.

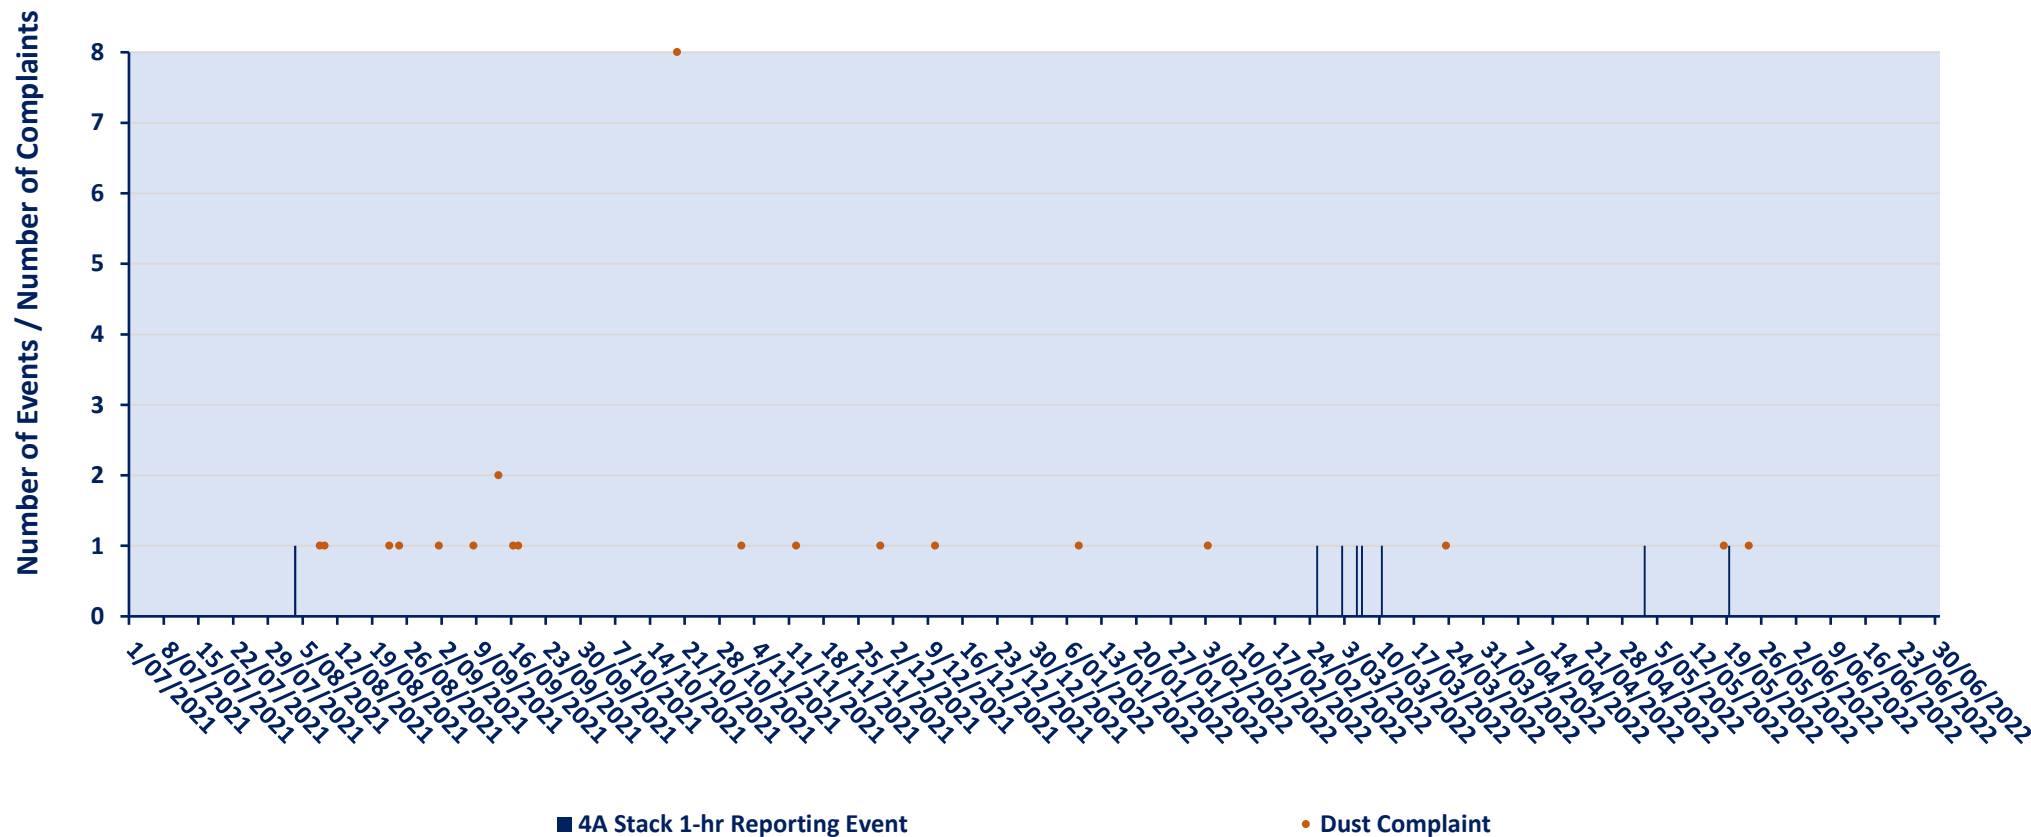
4A Stack 1-hour Reporting Events compared against All Dust Complaints  
1/7/2021 - 30/6/2022

Dust complaints did not coincide with 4A stack 1-hr reporting events, indicating dust complaints are not related to stack emissions.

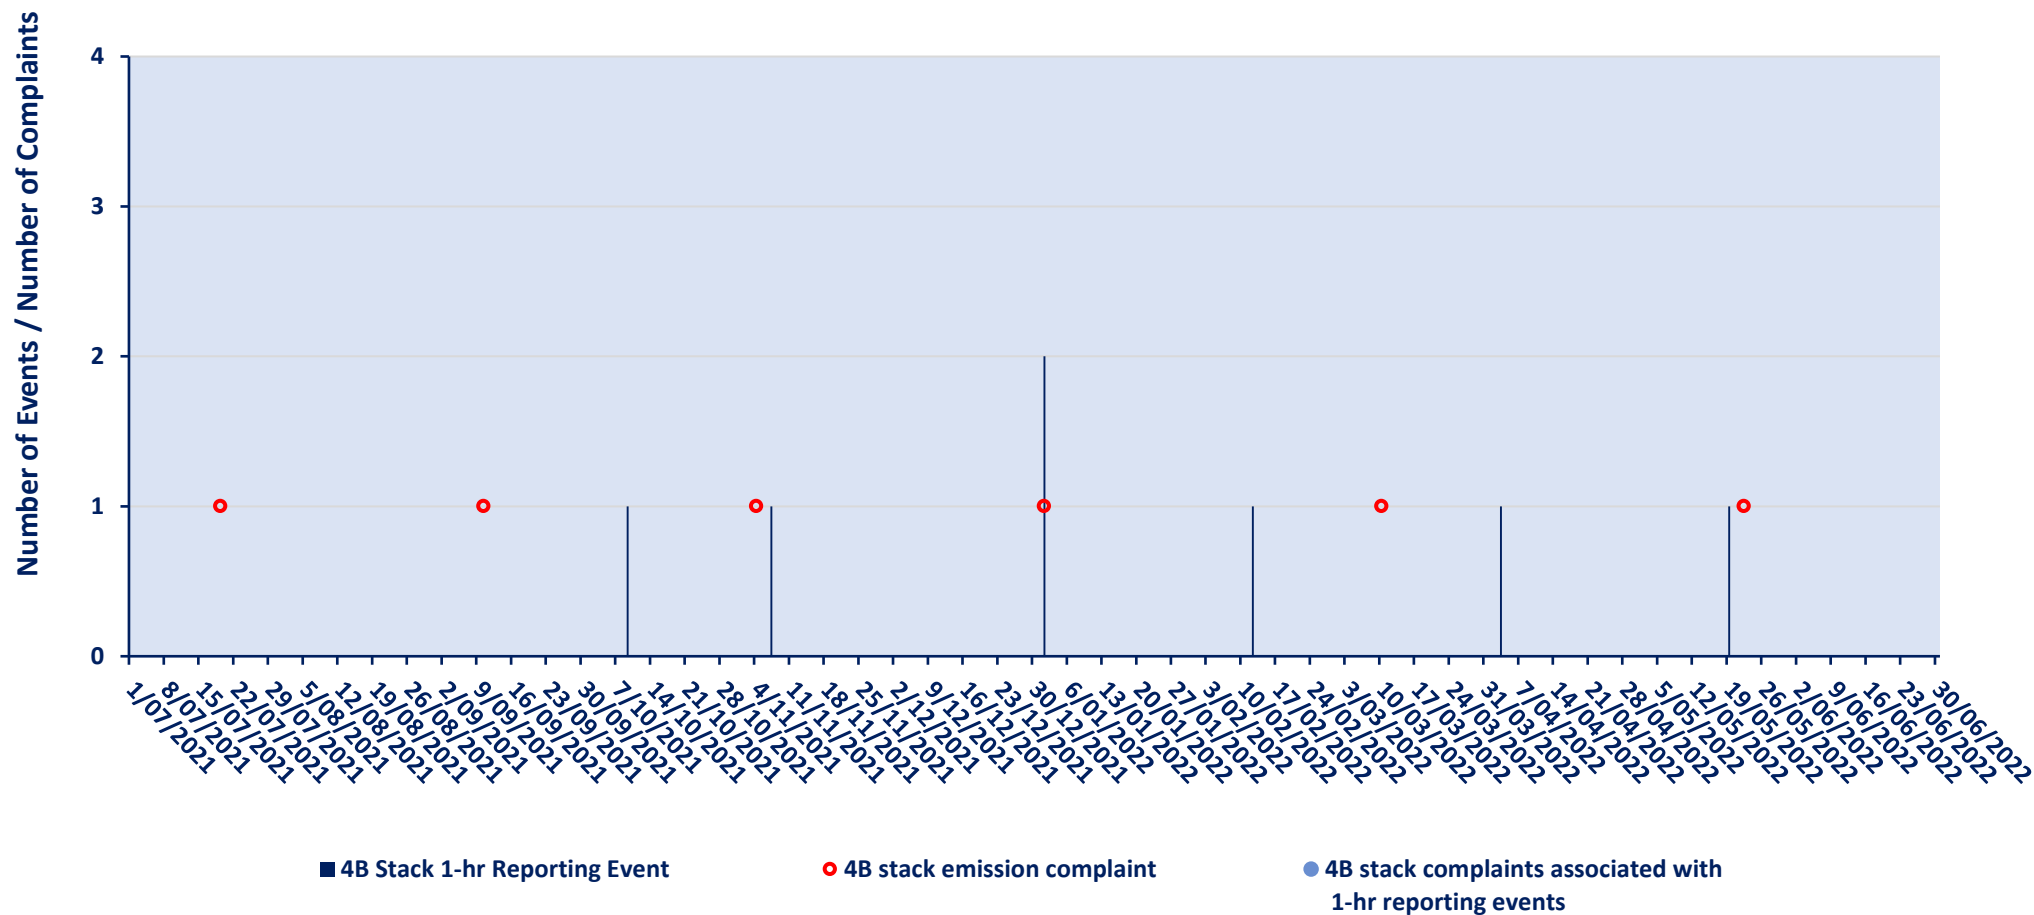
4B Stack 1-hour Reporting Events compared against Stack Emission Complaints  
1/7/2021 - 30/6/2022

One stack emission complaint preceded a 4B stack 1-hr reporting events by 2 hrs 20 mins.  
All other stack emission complaints did not coincide with a 4B stack 1-hr reporting event

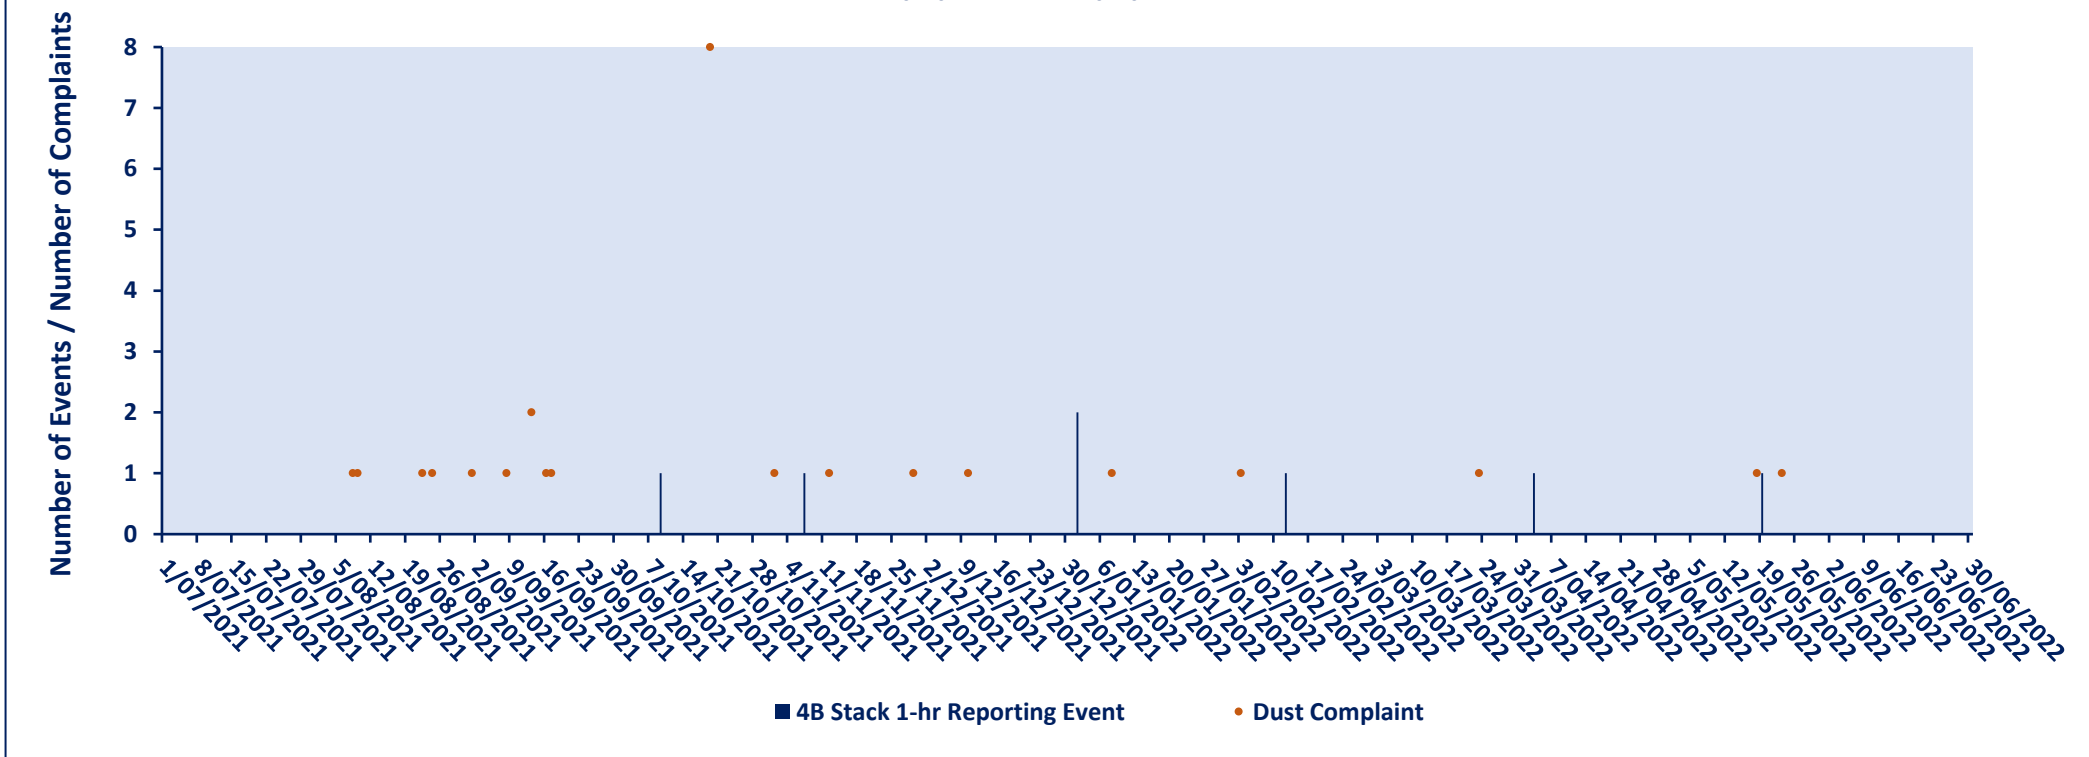
4B Stack 1-hour Reporting Events compared against All Dust Complaints Complaints  
1/7/2021 - 30/6/2022

Dust complaints did not coincide with 4B stack 1-hr reporting events, indicating dust complaints are not related to stack emissions.
