Stack Particulate Management Plan Annual Stack Particulate Report

COMPLIANCE DATE: 31/10/23 – Annual Report 2023 (July 2022-June 2023)

EPA Licence 1126: Stack Particulate Management Plan (U - 1556)

Licensed site: Adelaide Brighton Cement, Birkenhead Works

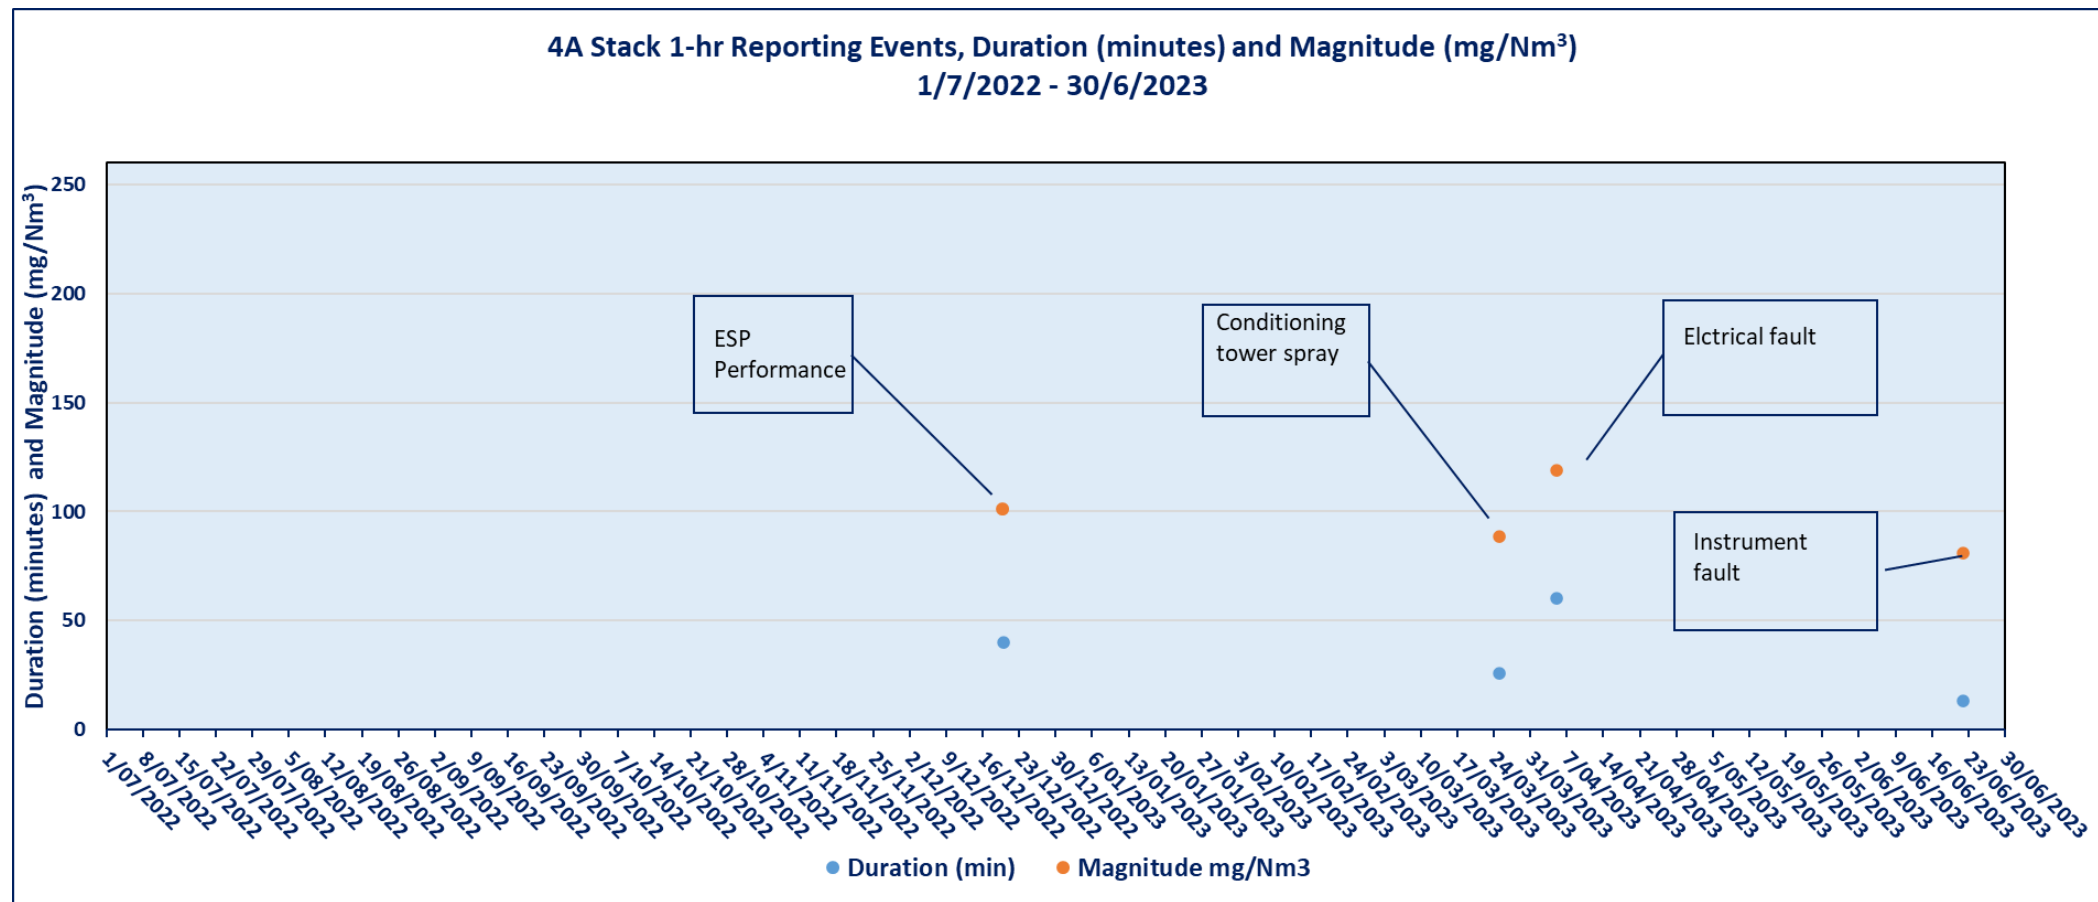
4A Stack:

There were 4, 1-hr reporting events for the year.

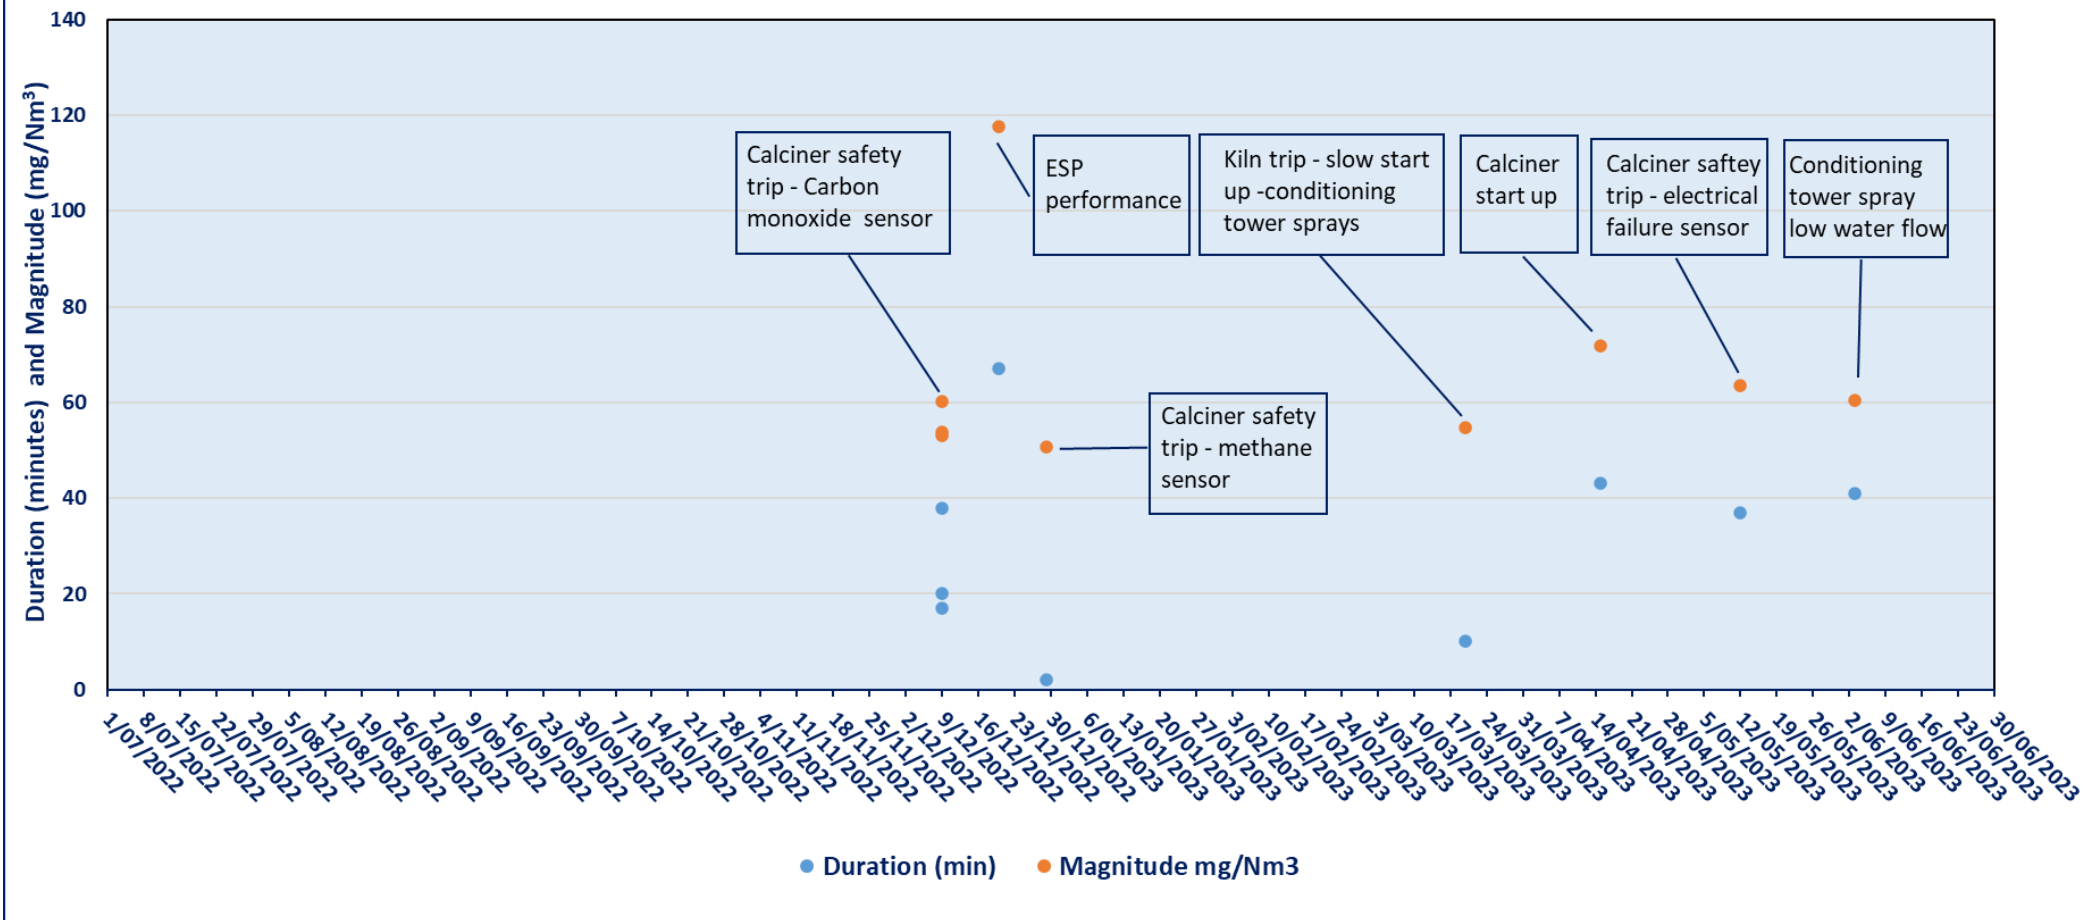
4B Stack 1-hr Reporting Events, Duration (minutes) and Magnitude (mg/Nm³)
1/7/2021 - 30/6/2022

There were 9, 1-hr reporting events for the year.

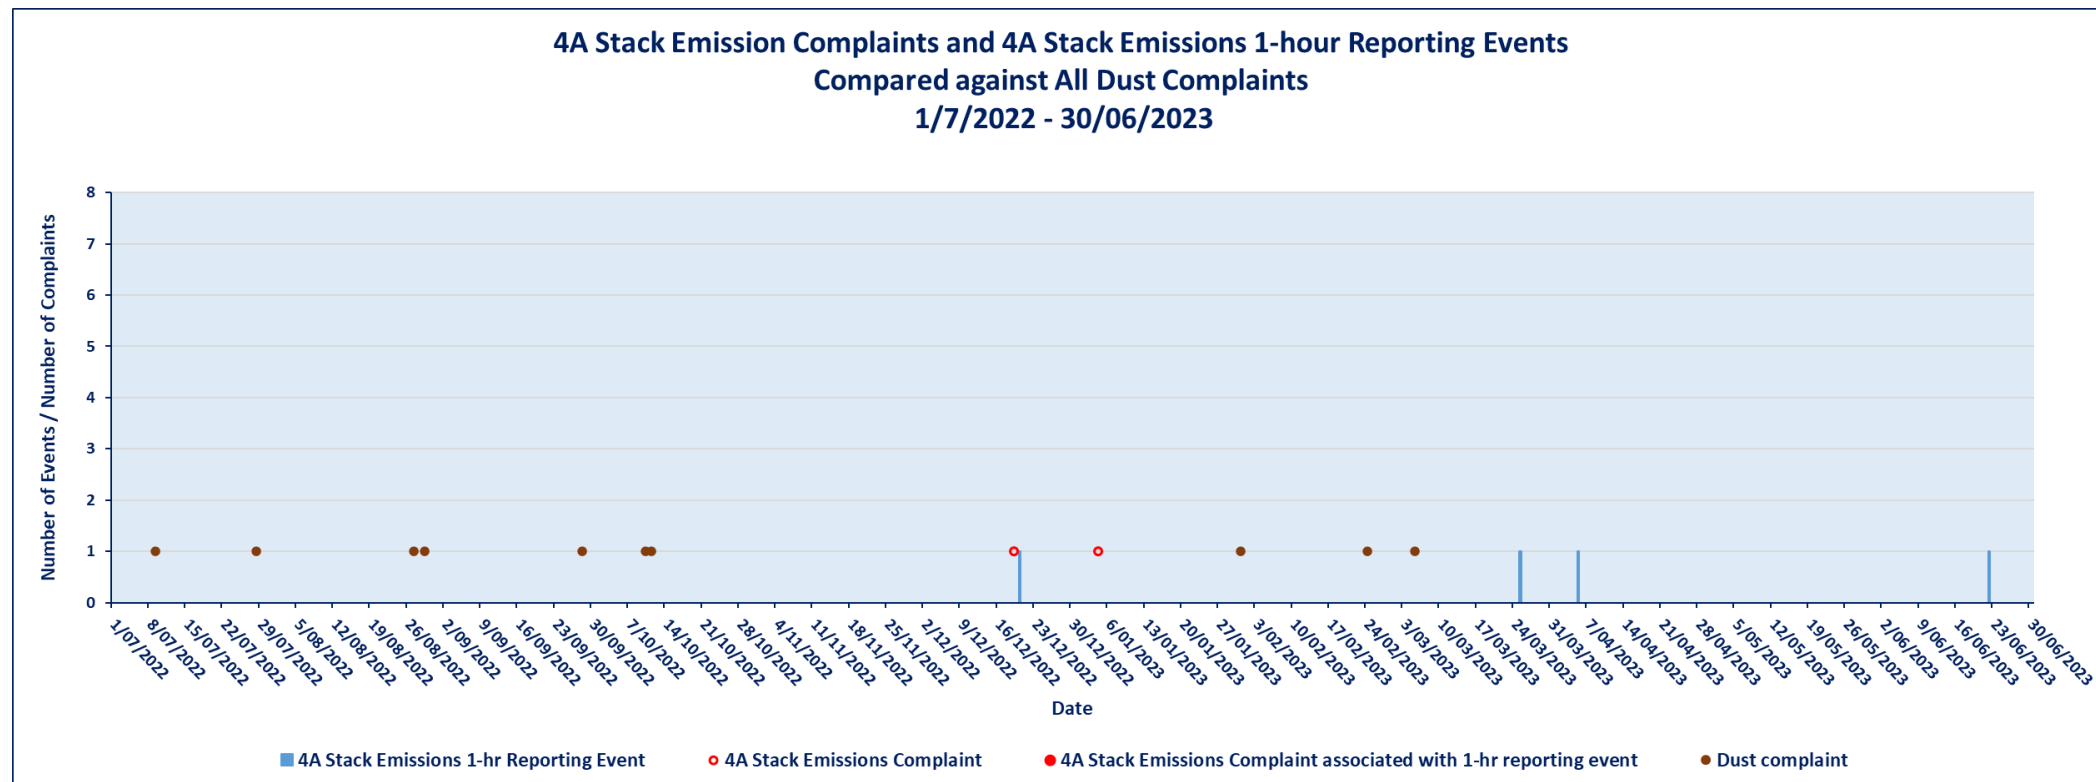
4A Stack:

Stack emission complaints did not coincide with 4A stack 1-hr reporting events.

Dust complaints did not coincide with 4A stack 1-hr reporting events, indicating dust complaints are not related to stack emissions.

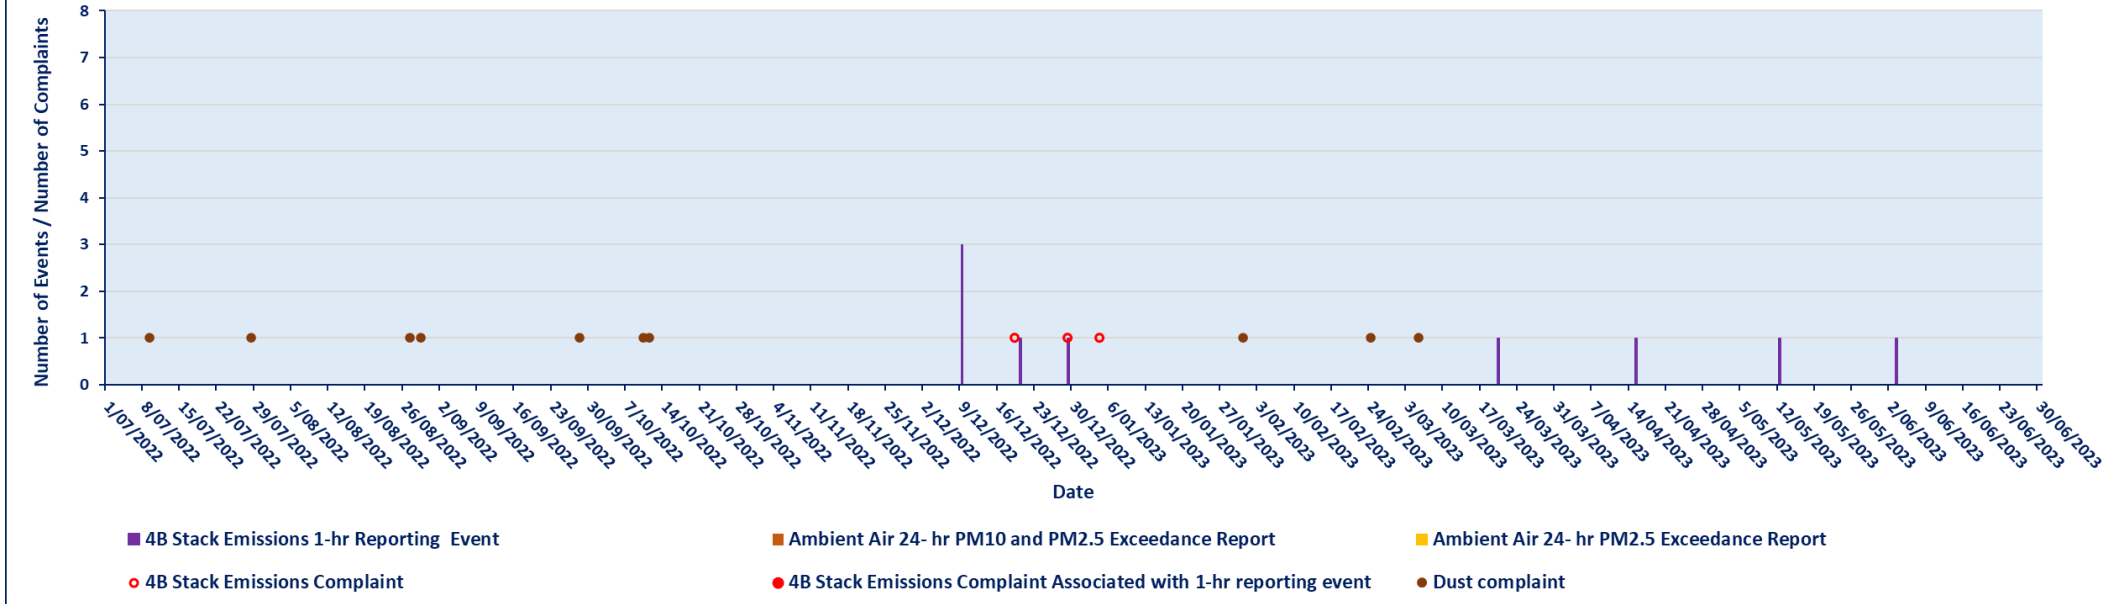
**4B Stack Emission Complaints and All Dust Complaints Compared against
4B Stack Emissions 1-hour Reporting Events and Ambient 24 hr PM₁₀ and PM_{2.5} Exceedance Reports
1/7/2022 - 30/06/2023**

Stack emission complaints did not coincide with 4B stack 1-hr reporting events, except possible on one occasion 29/12/2023.

Dust complaints did not coincide with 4B stack 1-hr reporting events, indicating dust complaints are not related to stack emissions.
