# Stack Particulate Management Plan Annual Stack Particulate Report

COMPLIANCE DATE: 31/10/24 – Annual Report 2024 (July 2023-June 2024)

EPA Licence 1126: Stack Particulate Management Plan (U - 1556)

**Licensed site: Adelaide Brighton Cement, Birkenhead Works**

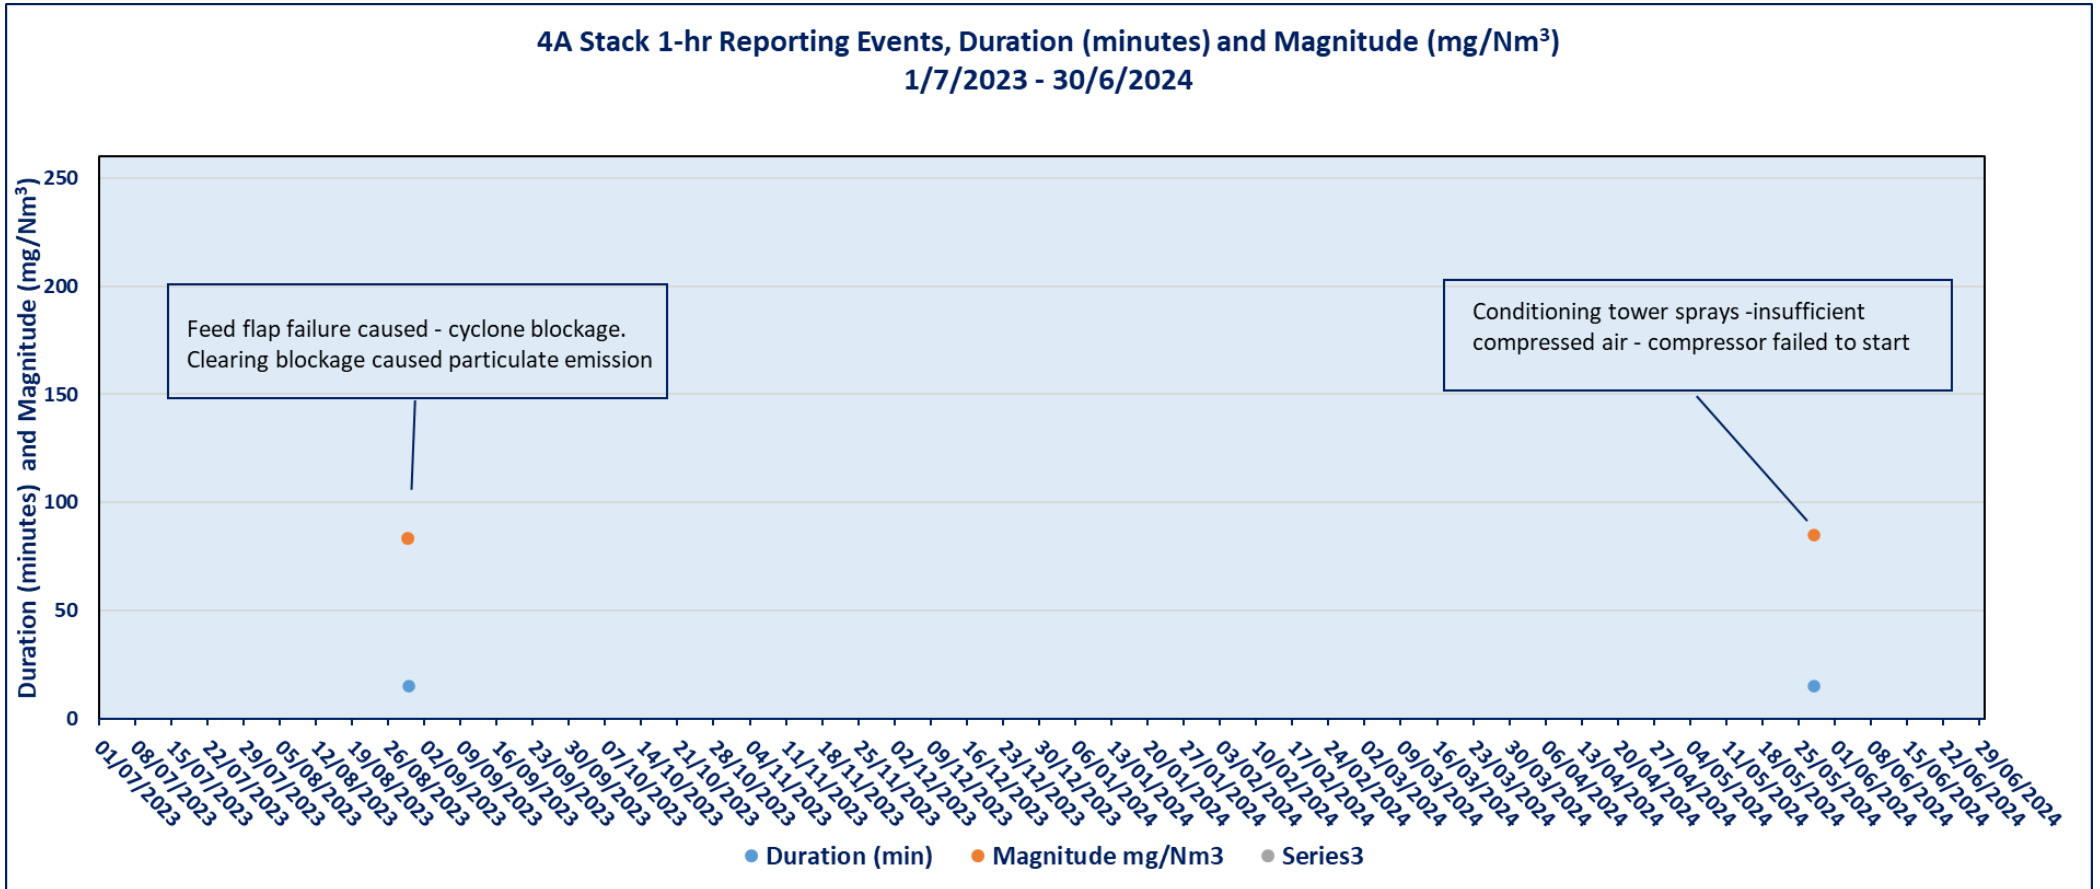
4A Stack:

There were 2, 1-hr reporting events for the year.

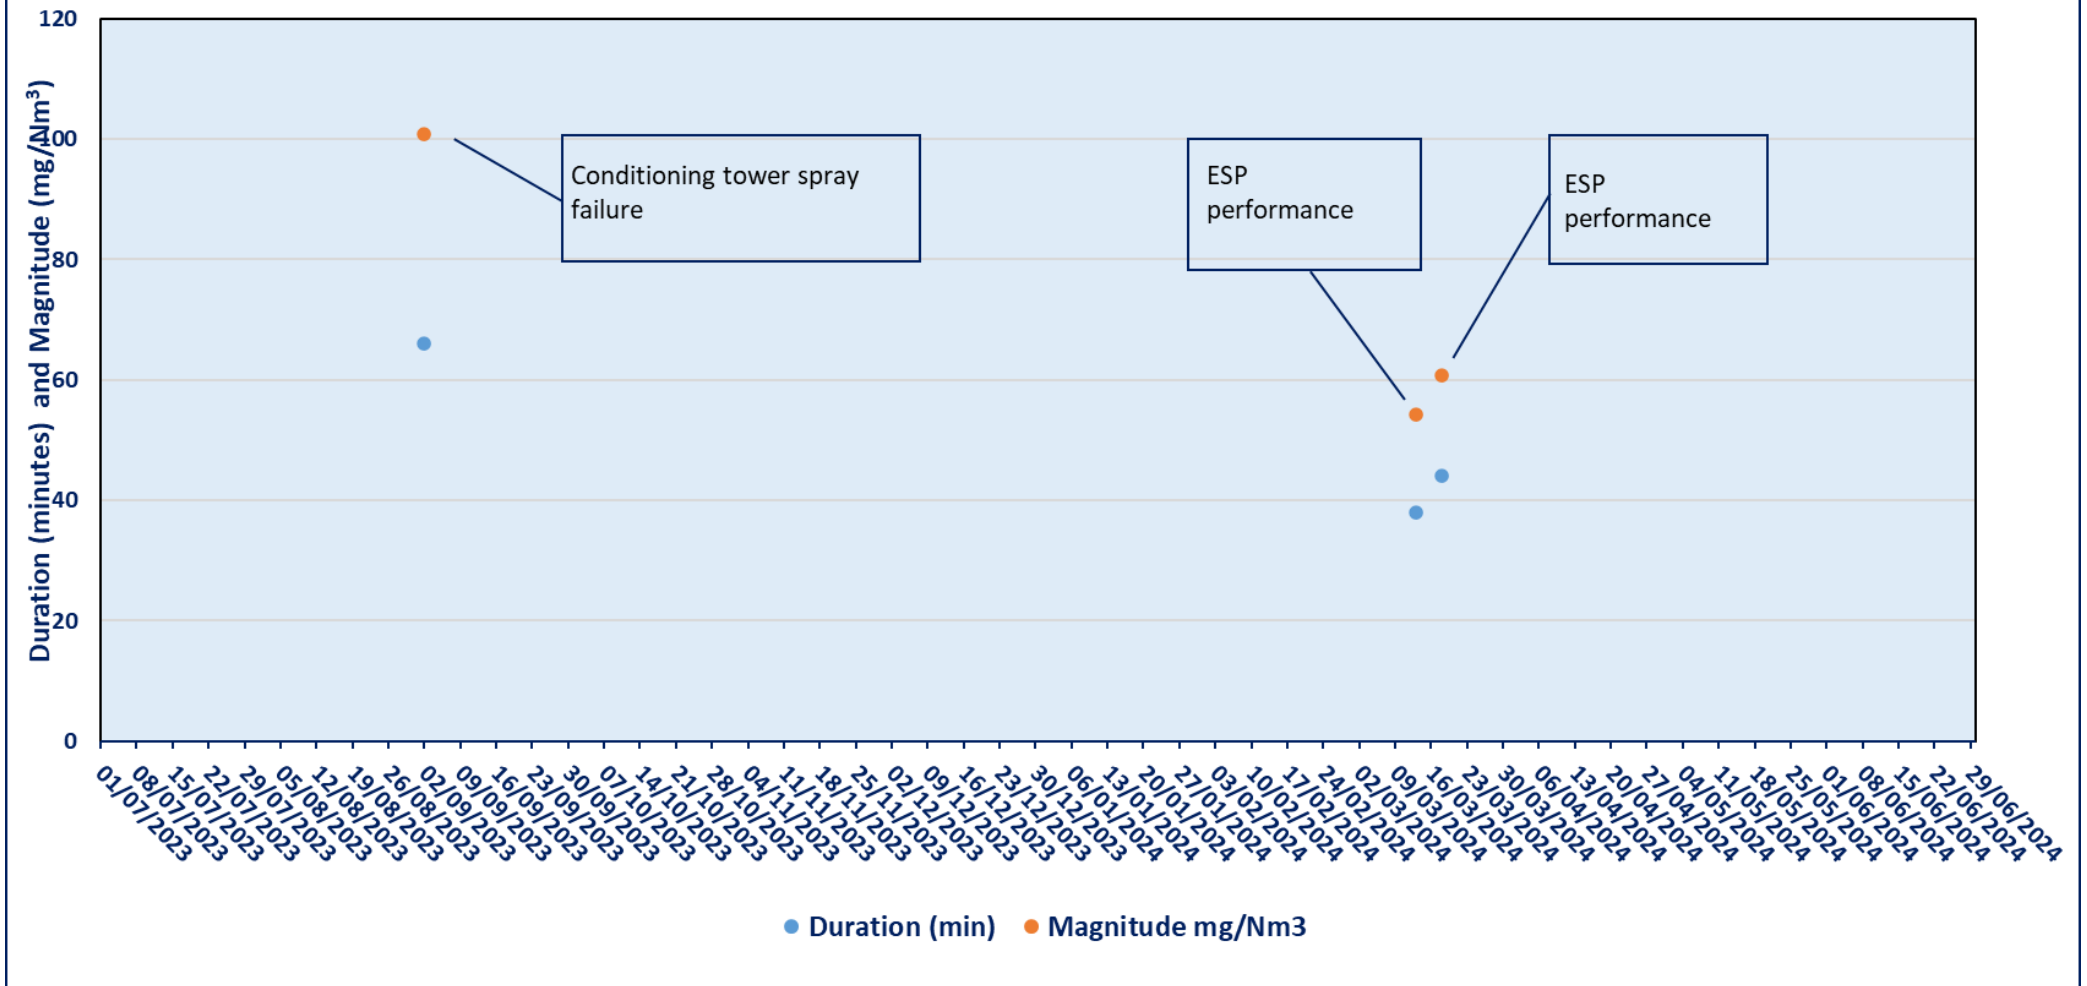
4B Stack 1-hr Reporting Events, Duration (minutes) and Magnitude (mg/Nm<sup>3</sup>)  
1/7/2023 - 30/6/2024

There were 3, 1-hr reporting events for the year.

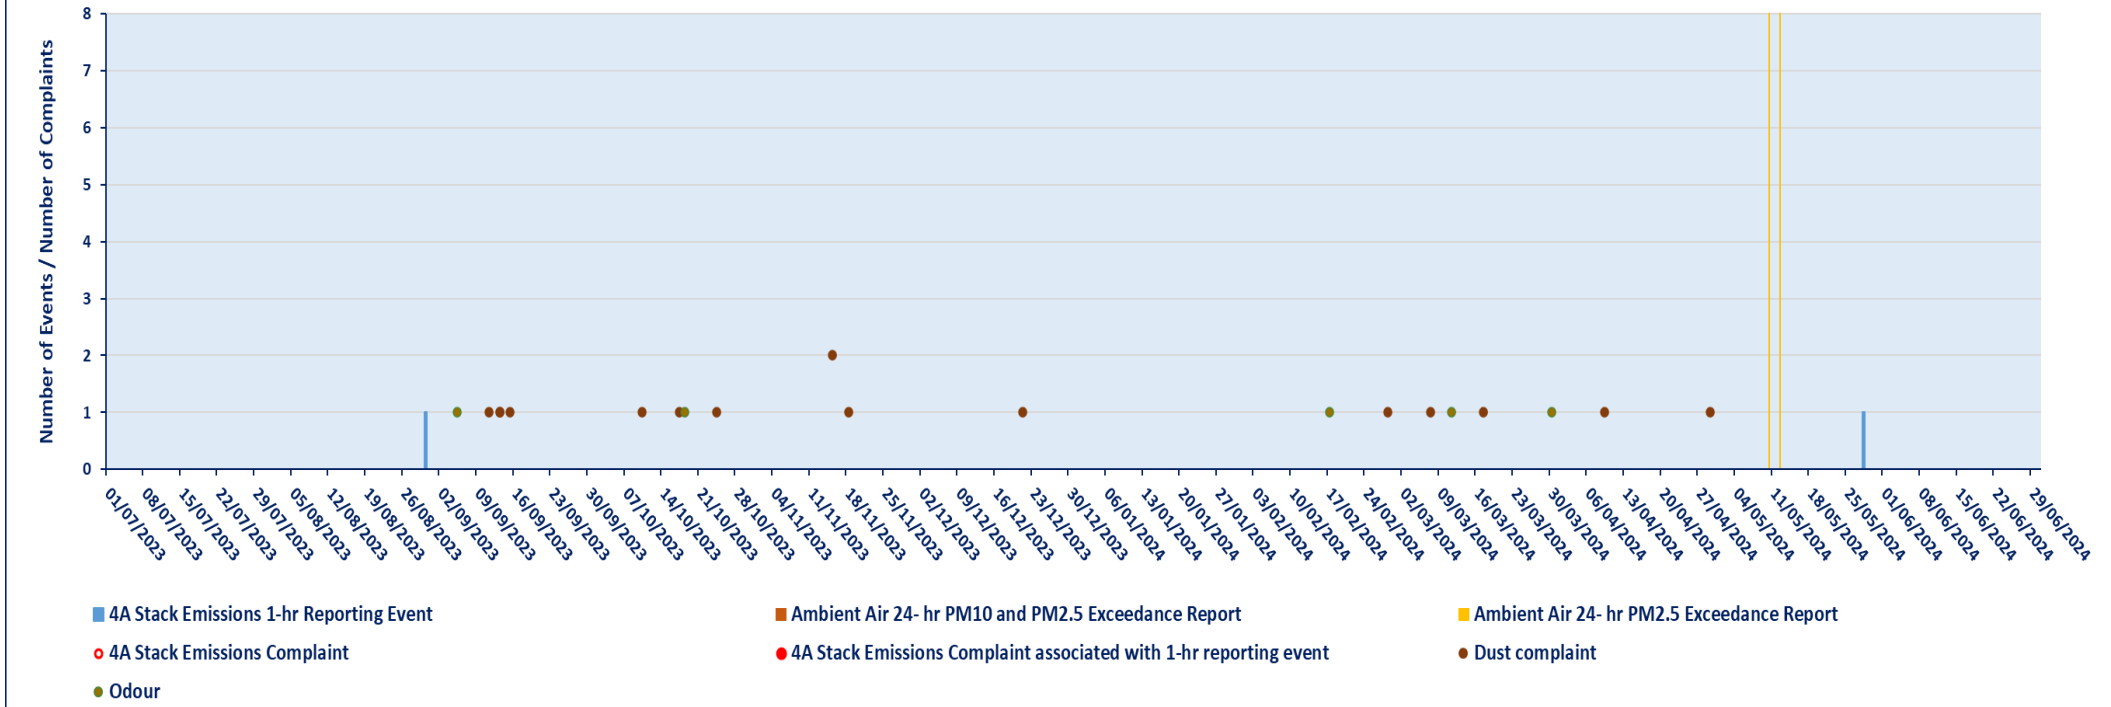
4A Stack Emission Complaints and Dust Complaints and Odour Complaints Compared against  
4A Stack Emissions 1-hour Reporting Events and Ambient 24 hr PM<sub>10</sub> and PM<sub>2.5</sub> Exceedance Reports  
1/7/2023 - 30/06/2024

Stack emission complaints did not coincide with 4A stack 1-hr reporting events.

Dust complaints did not coincide with 4A stack 1-hr reporting events, indicating dust complaints are not related to stack emissions.

Odour complaints did not coincide with 4A stack 1-hr reporting events.

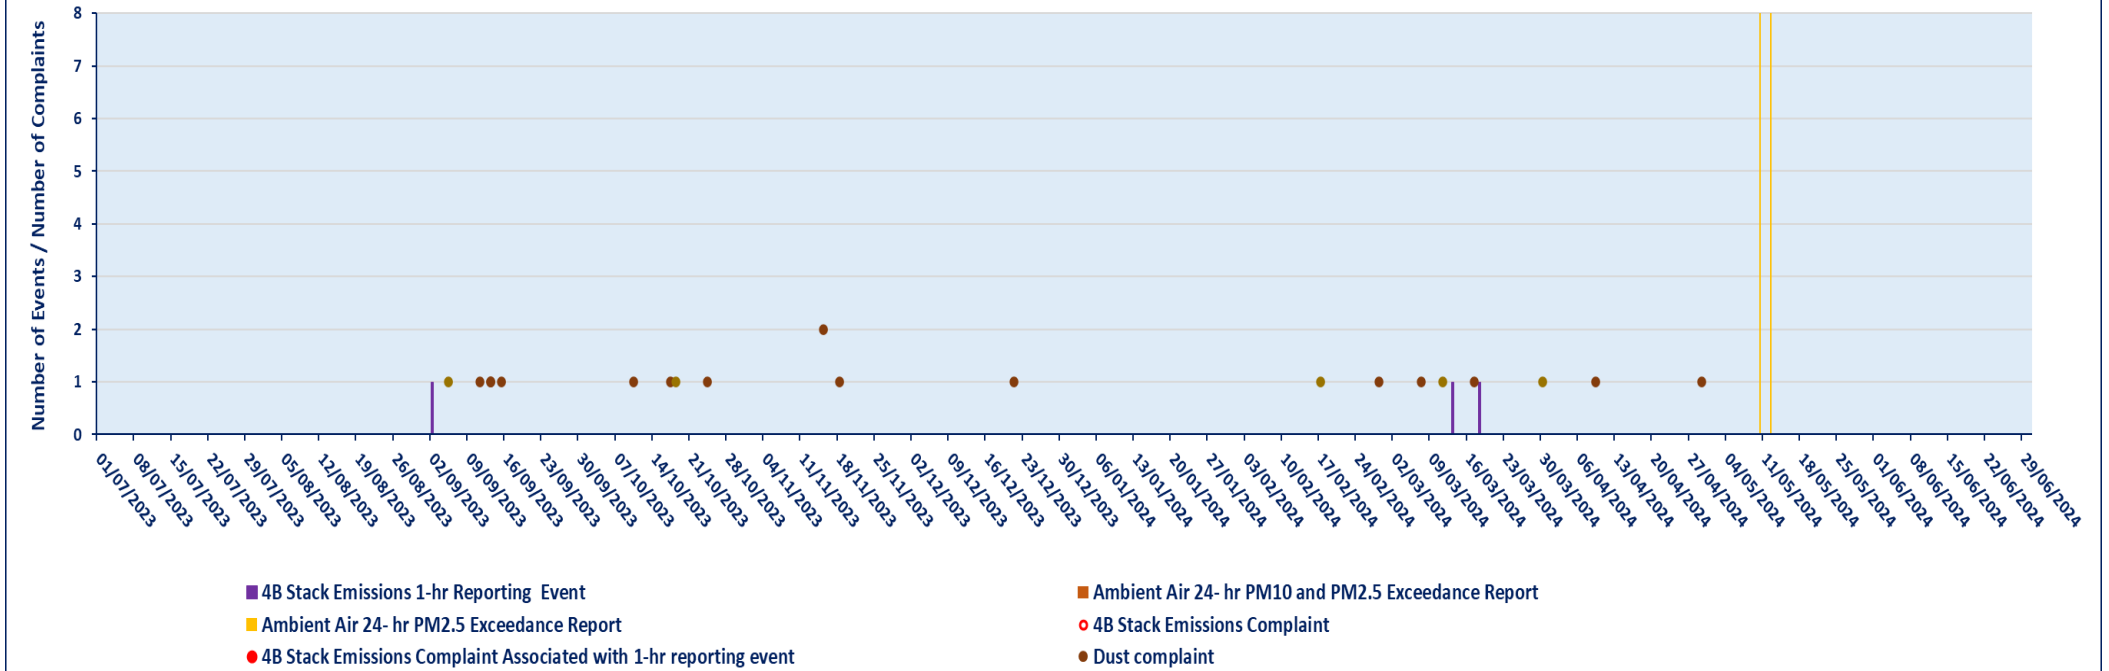
4B Stack Emission Complaints and Dust Complaints and Odour Complaints Compared against  
4B Stack Emissions 1-hour Reporting Events and Ambient 24 hr PM<sub>10</sub> and PM<sub>2.5</sub> Exceedance Reports  
1/7/2022 - 30/06/2023

Stack emission complaints did not coincide with 4B stack 1-hr reporting events.

Dust complaints did not coincide with 4B stack 1-hr reporting events, indicating dust complaints are not related to stack emissions.

Odour complaints did not coincide with 4B stack 1-hr reporting events.
