## QUARTERLY NOISE MANAGEMENT REPORT FOR BIRKENHEAD WORKS

**COMPLIANCE DATE: 14/05/2021– Quarter 1 2021**  
**EPA Licence 1126: Noise Management Plan (U-787)**

**Licensed site: Adelaide Brighton Cement, Birkenhead Works**

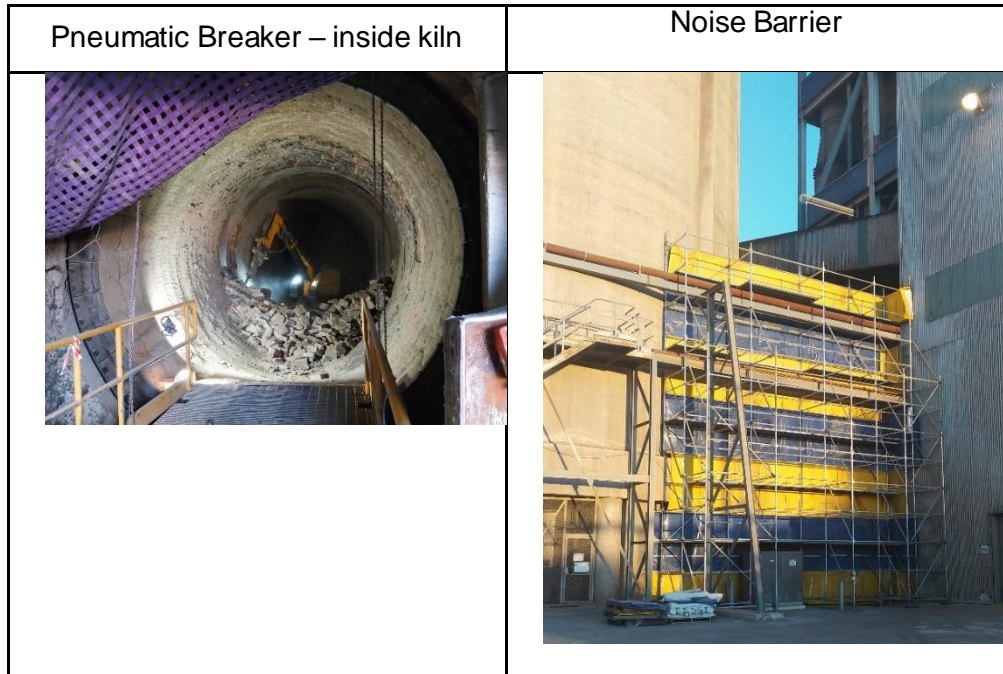
- Remote controlled pneumatic breaker (Brokk) – allows for better control of the activity
- A 14m high noise barrier was installed
- Noisiest activities scheduled during the daytime period and stopped at 10 pm
- Daily team briefing / HSE toolbox meetings including
  - community impact awareness
  - community interactions

Attended noise surveys by acoustic consultants over 3 nights to assess refractory demolition noise impacts showed that

- Demolition noise was detected intermittently in some areas of the community, however sound levels were below night-time noise criteria in most areas.
- Some areas were influenced by nearby traffic and other ambient sources
- The acoustic survey shows that while demolition activity is audible there is no apparent increase in noise levels

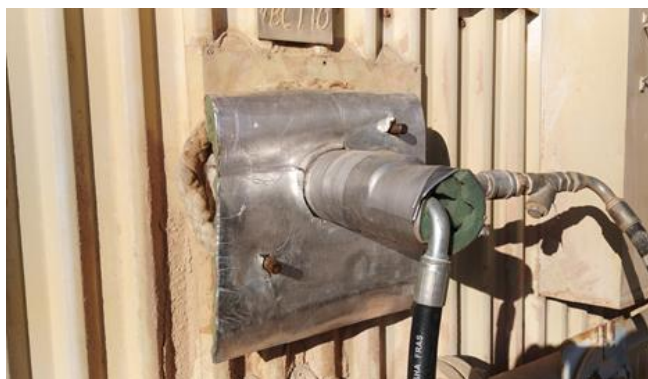
Spray nozzle lagged with Pyrotech Soundlag 4525C

Investigation into a resident's complaint of an intermittent whistling noise, identified the source of the noise to be associated with the operation of the 4B Conditioning Tower water sprays.

Initial response to the complaint was to wrap the spray nozzles with Kaowool insulation blanket, which addressed the noise complaint at the time.

Acoustic treatments are being evaluated to determine a suitable long-term noise abatement solution.

Moulded rubber shrouds were manufactured and installed on the spray nozzles, initial results were promising, but reoccurrence of the complaint has occurred.

Pyrotech Soundlag 4525C (a highly flexible foam-based composite acoustic pipe lagging product), has been installed on the spray nozzle pipework and is currently being evaluated for effectiveness.
