QUARTERLY NOISE MANAGEMENT REPORT FOR BIRKENHEAD WORKS

COMPLIANCE DATE: 15/05/2022– Quarter 1 2023
EPA Licence 1126: Noise Management Plan (U-787)

Licensed site: Adelaide Brighton Cement, Birkenhead Works

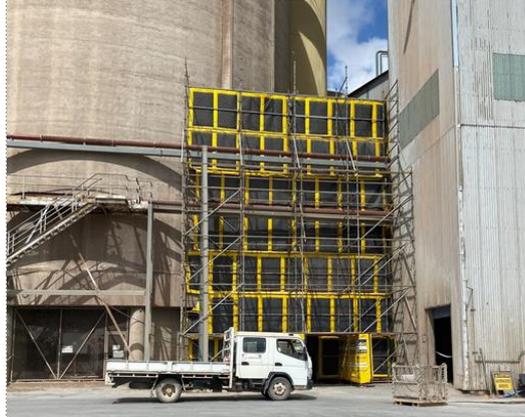
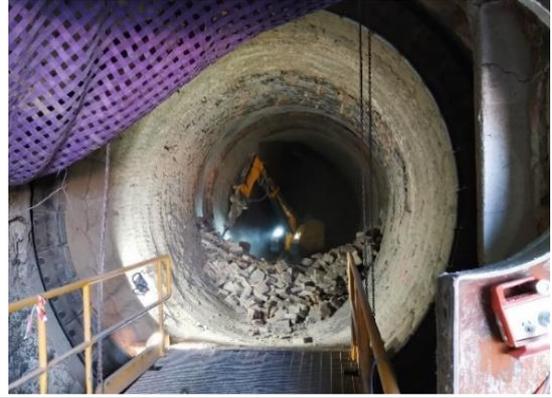
Photo of noise attenuation barrier and pneumatic breaker in the kiln

During the annual plant shutdown, the following controls were put in place to reduce the noise associated with kiln refractory demolition

- Remote controlled pneumatic breaker (Brokk) – allows for better control of the activity
- A 14m high noise barrier was installed
- Noisiest activities scheduled during the daytime period and stopped at 10 pm
- Daily team briefings
